Los Angeles County Fire Department Health Hazardous Materials Division Emergency Operations Section

FRUITLAND MAYWOOD Magnesium Explosion/fire

June 14, 2016

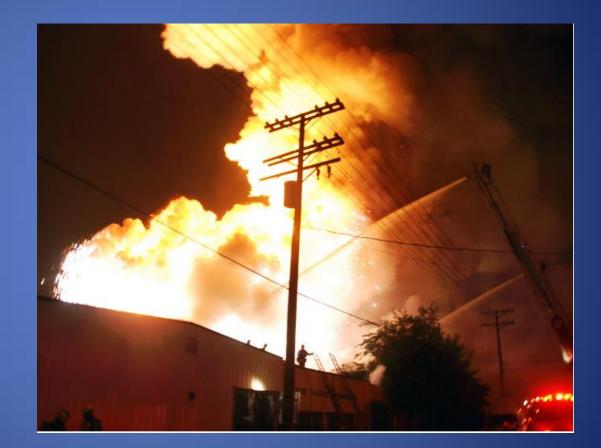
in the morning.
 (LACoFD) units
 responded to a 3rd
 alarm commercial
 building fire, located
 at 3570 Fruitland
 Avenue in the City of
 Maywood.
- Panda International Trading (PIT)
- Propane and Waste Oil only HazMat Disclosed in CERS.
- Second Business, Sokor Metals (Not Permitted).

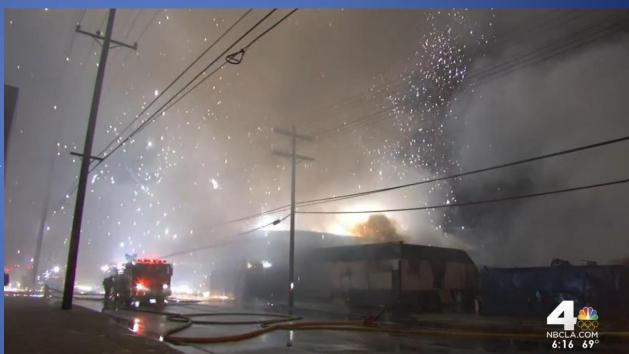
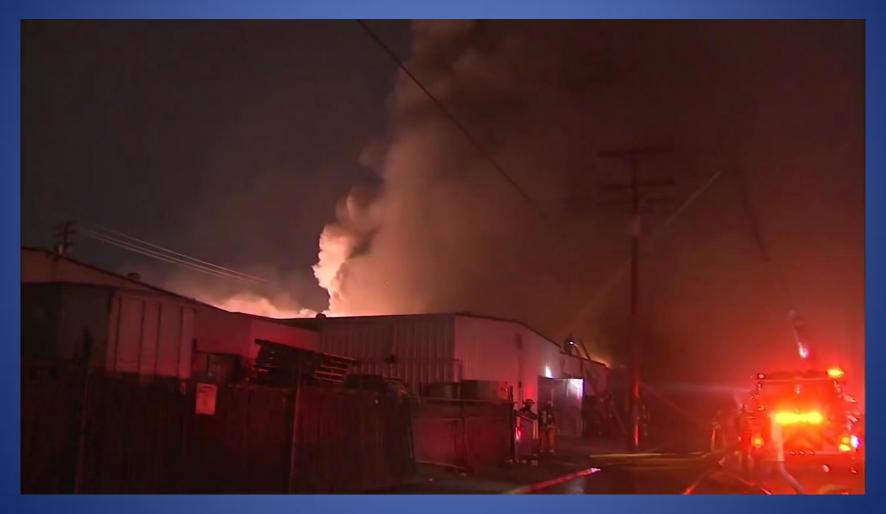
minutes into the fire
 intermittent, small
 explosions were
 observed.
- The explosions continued for approximately one hour, leading to a larger explosion that propelled burning metal and debris several hundred feet into the air.
- Burning magnesium, with the addition of fire suppression water, would account for the explosions observed.

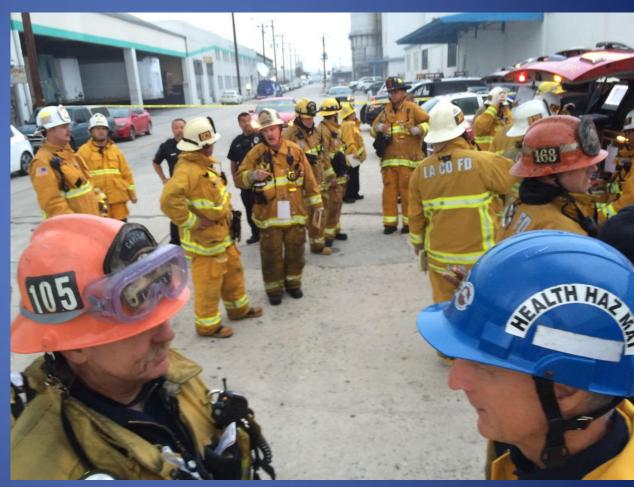
- Chemicals of Concern (COC's) heavy metals, Nitric & Hydrochloric Acid 1:3 Aquaregia
- Air monitoring
- Run off
- Responders and Public Exposure
- Gross decontamination of vehicles and turn outs
- EOS made referrals to AQMD, Public Health, and EPA.

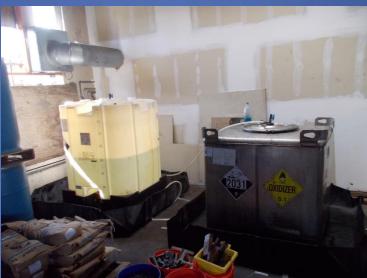
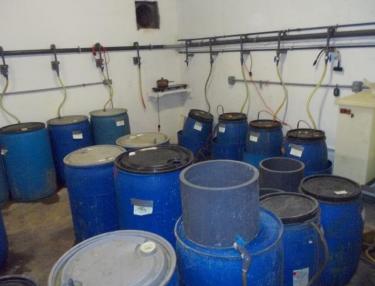
- EOS and Enforcement one week prior (6/7)
- A reaction occurred with incompatibles.
 Sokor Metals was cited and issued a Notice of Violation
- Aquaregia Nitric and Hydrochloric Acid 1:3 to extract Precious Metals No Permit
- Illegal Treatment

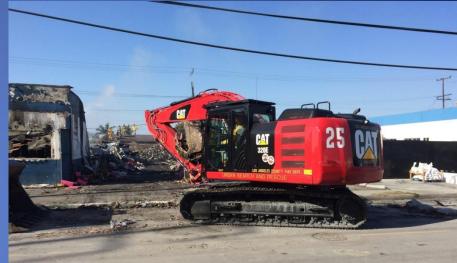
30 Hours to extinguish fire

Smother and Metl X

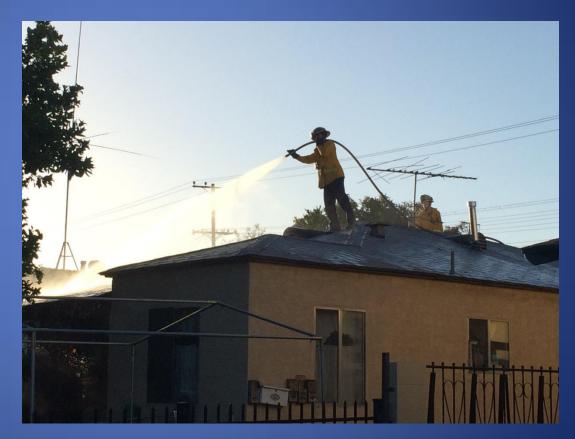
- Fire Fighters conducted Gross Decon on all homes on the North side of 52nd Street.
- Rinseate diked, contained, collected and profiled prior to disposal
- Responders turnouts bagged and sent out for cleaning

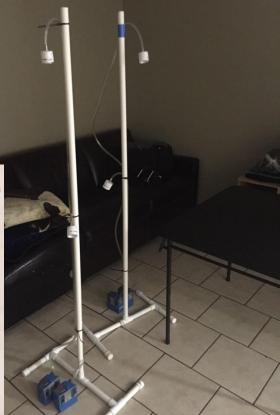
- Micro-Vac testing: Public Health.
- Measured total chromium based on chrome VI, copper, zinc and magnesium as an indicator.

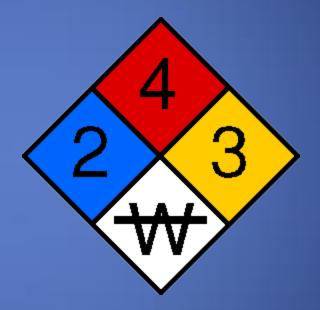
NFPA placard indicating water reactive may have avoided the explosion and resulting "near miss".
