U.S. Fire Administration/Technical Report Series

The East Bay Hills Fire

Oakland-Berkeley, California

USFA-TR-060/October 1991

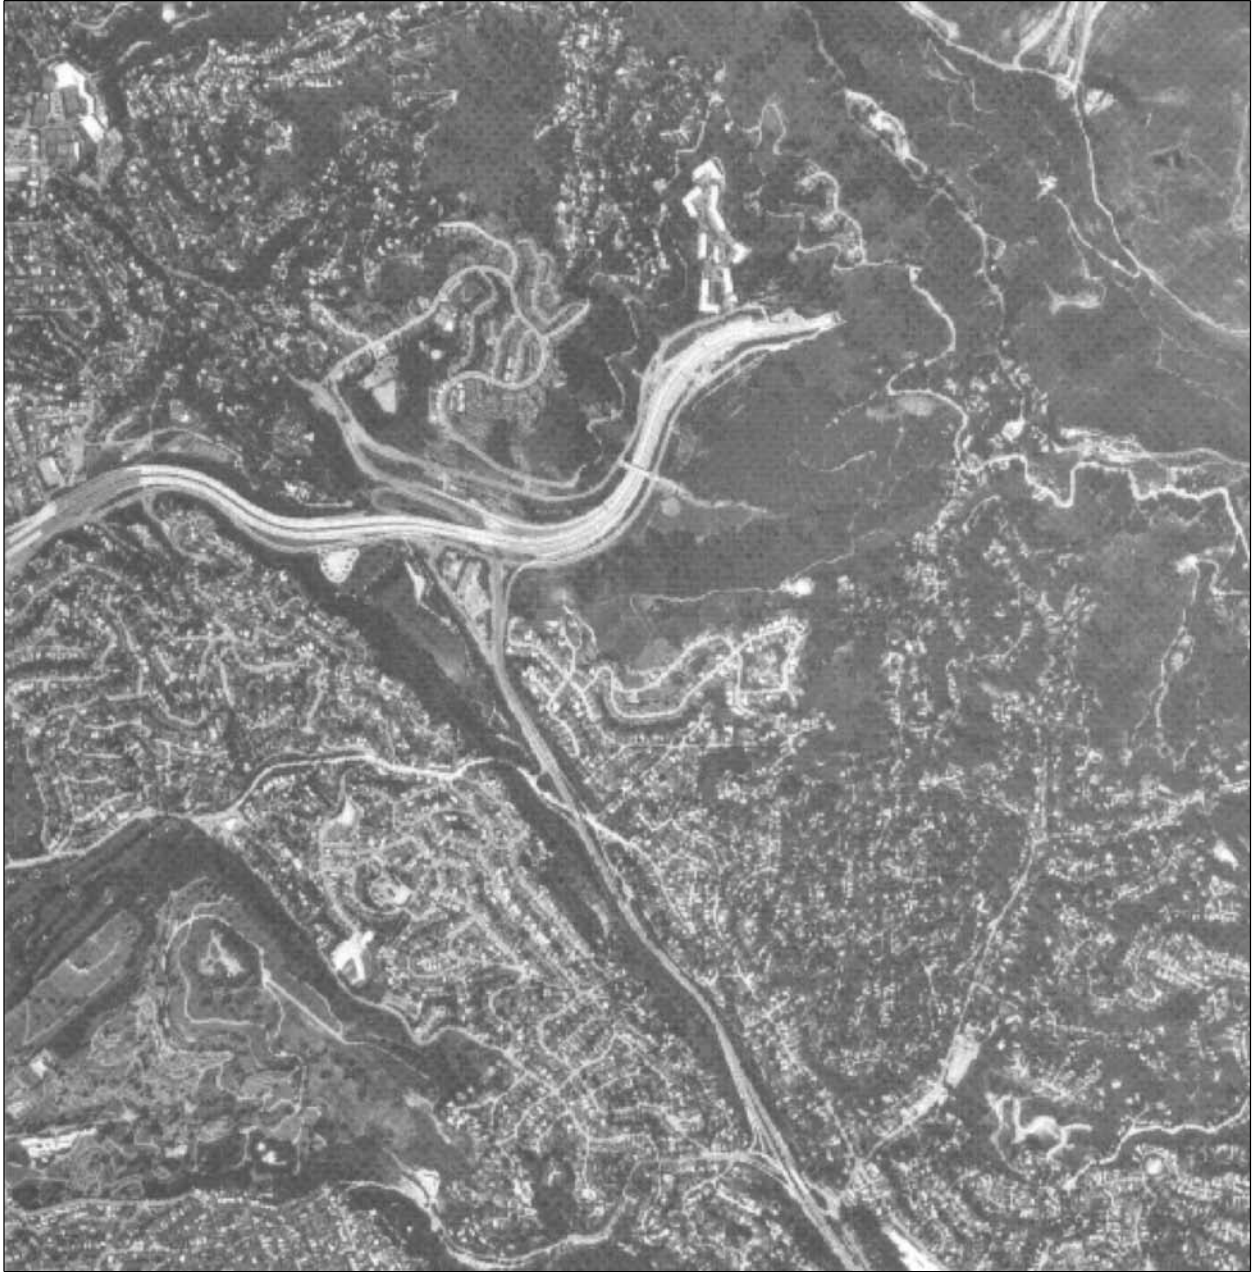
This is an aerial photograph of the East Bay Hills area taken before the fire. By comparing it with the map on page 3 the reader will be able to identify the Hiller Highlands, the Parkwood Apartments, Lake Temescal, the Claremont Hotel, and major roads. A similar photograph, taken after the fire, appears on page 64.

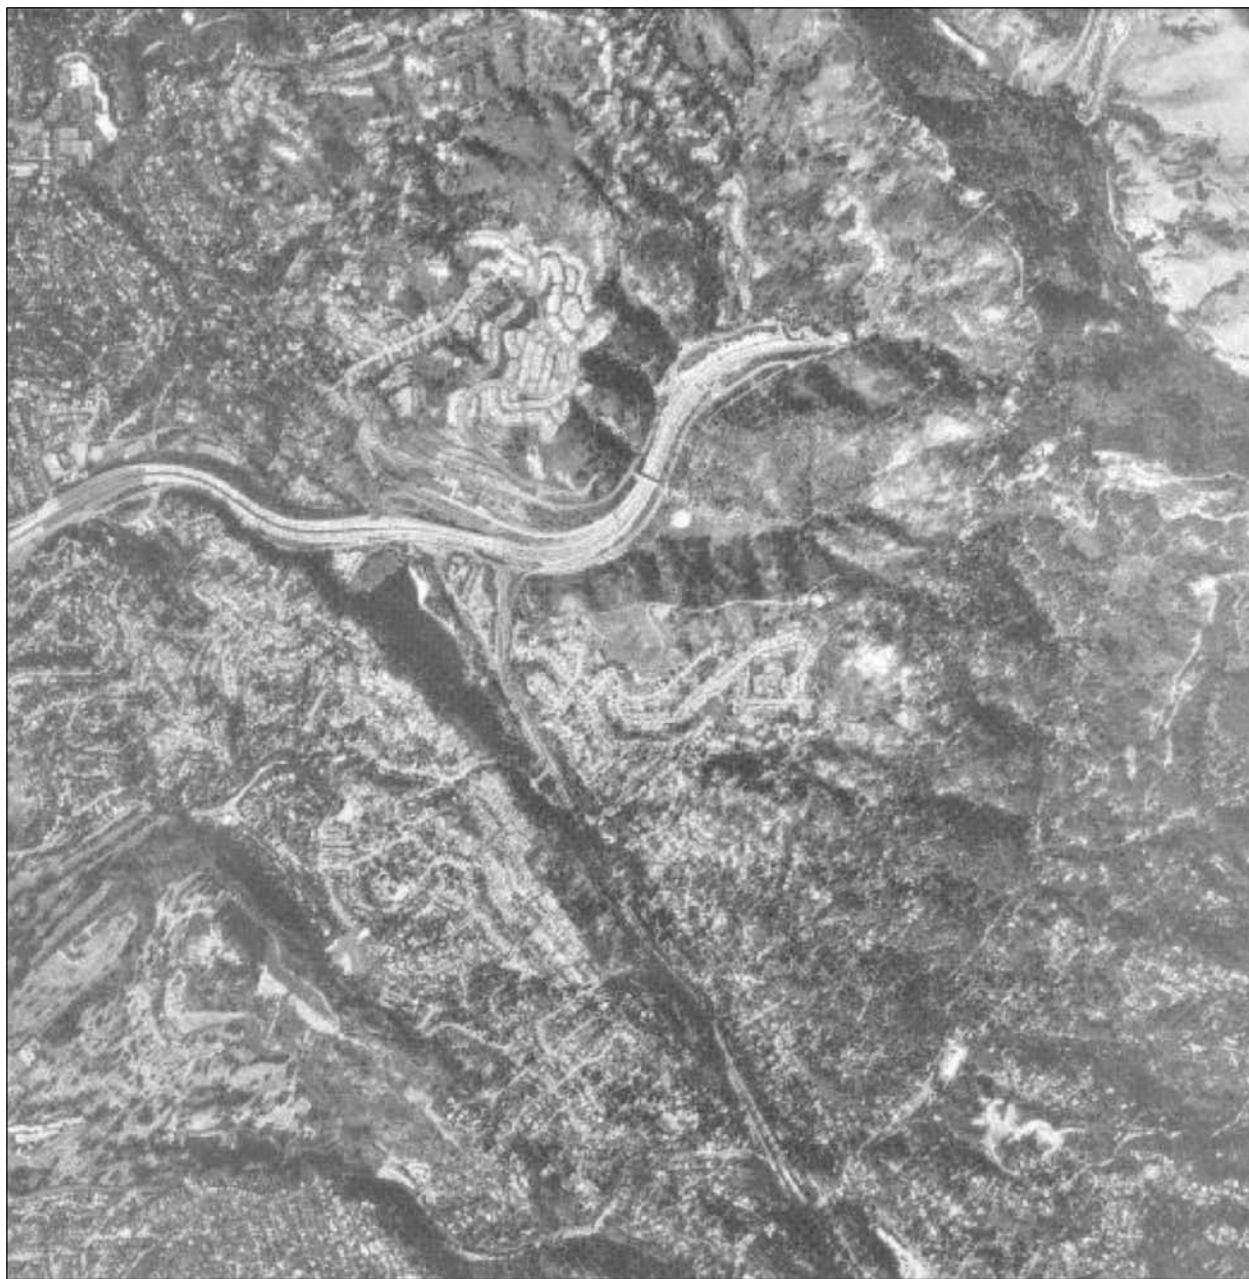
Aerial photograph taken after the fire. Area shown is the same as on page 9.
In total, 3,354 structures were destroyed.

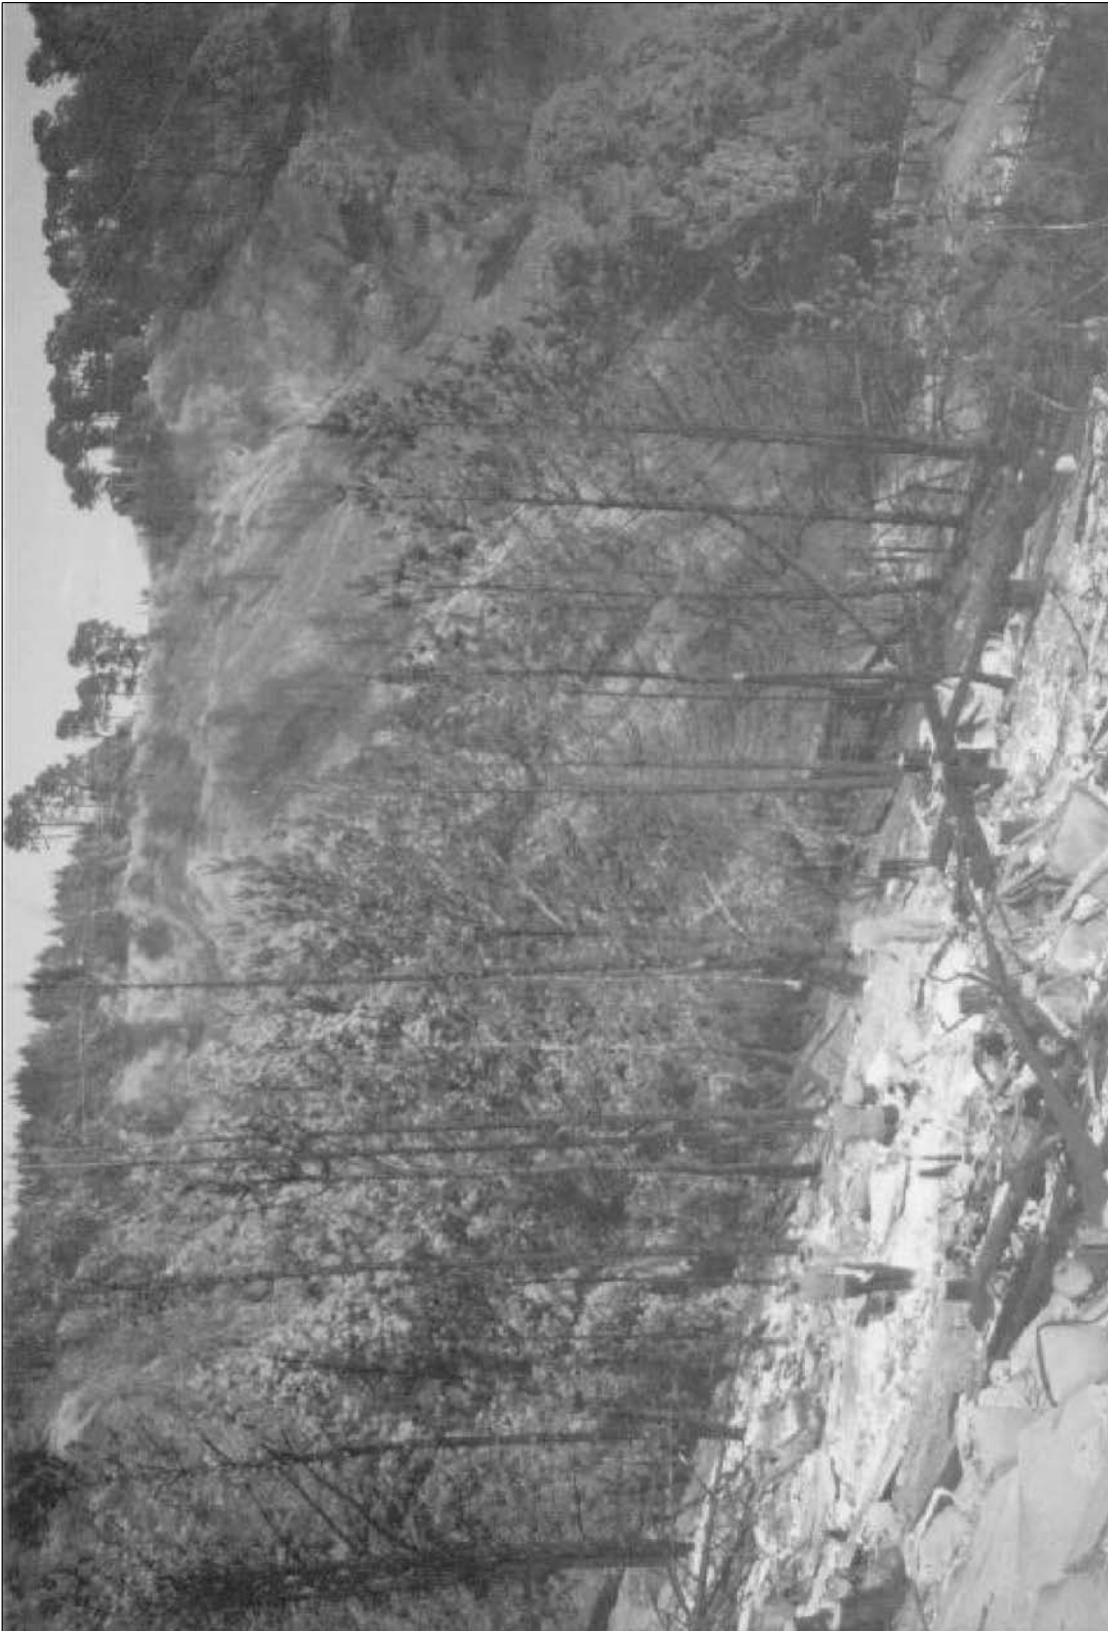
View looking toward the area of fire origin – on the grassy slope in the background. The left flank of the fire spread laterally behind the homes on Buckingham Boulevard and up toward the area in the foreground.

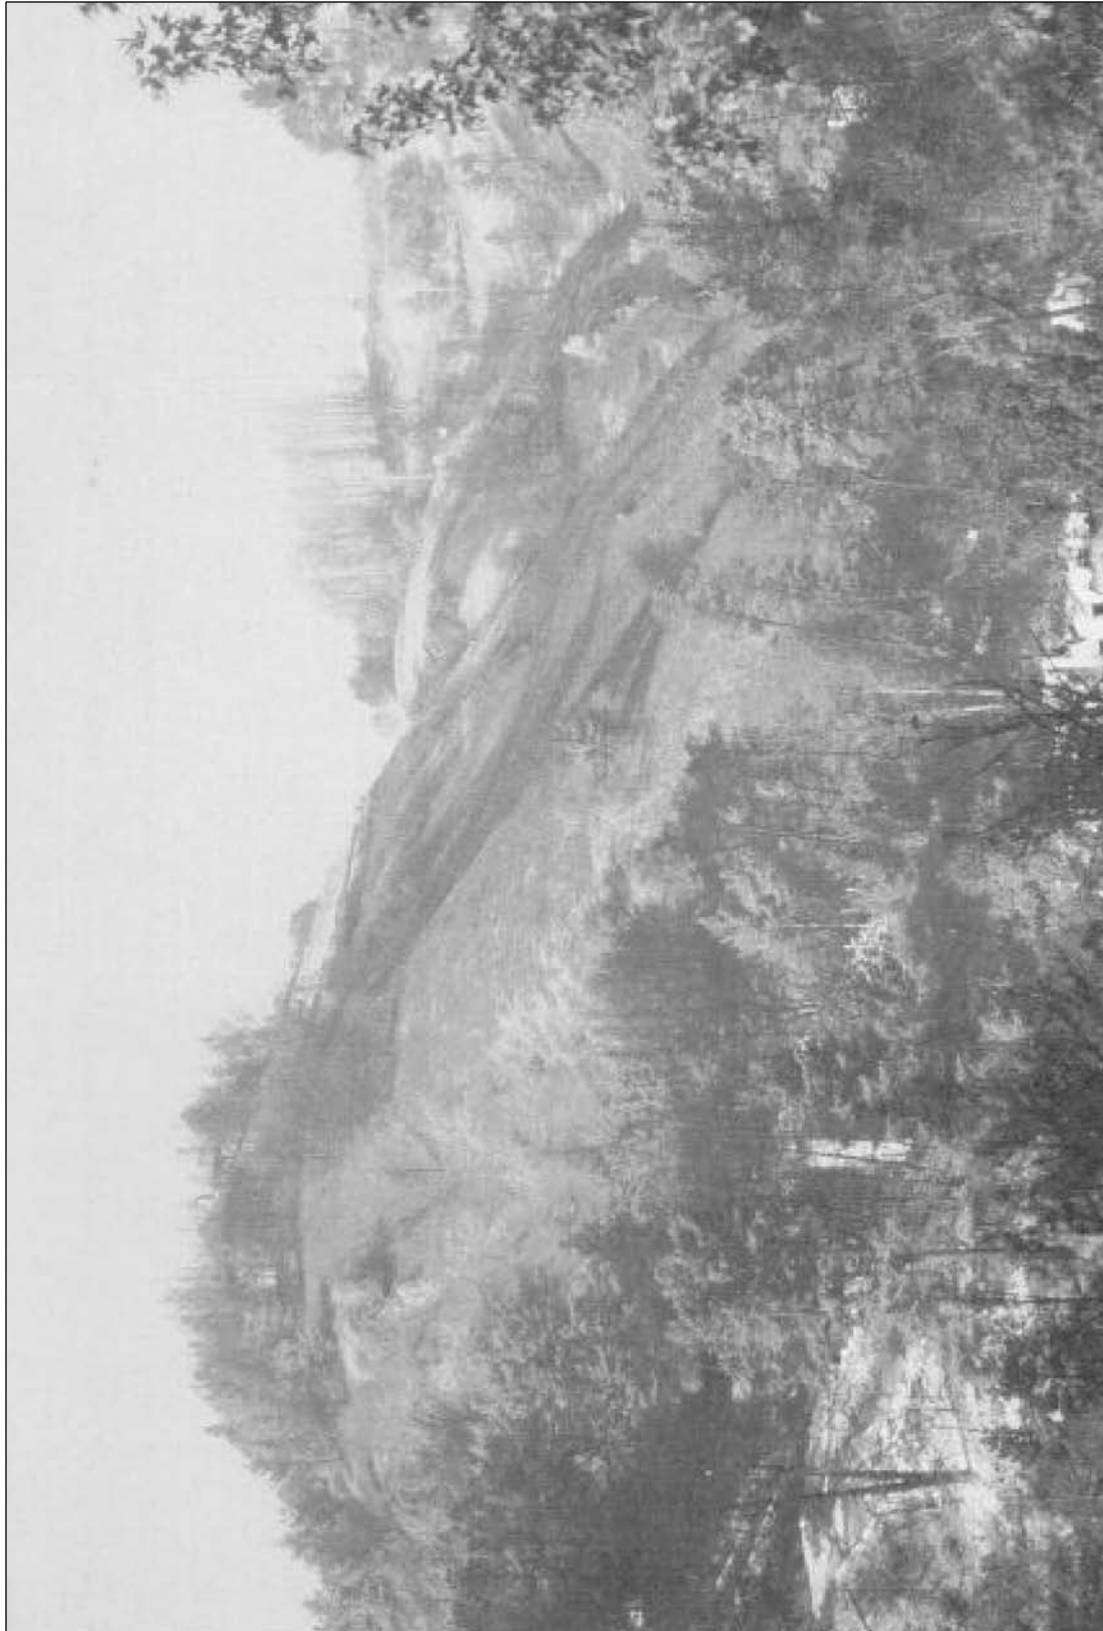
View of the area of fire origin as seen from the Parkwood Apartments. The Saturday fire burned up the grassy slope on the hills toward Marlborough Terrace and the radio tower on Grizzly Peak. The fire on Sunday broke out in the lower part of the original burn area.

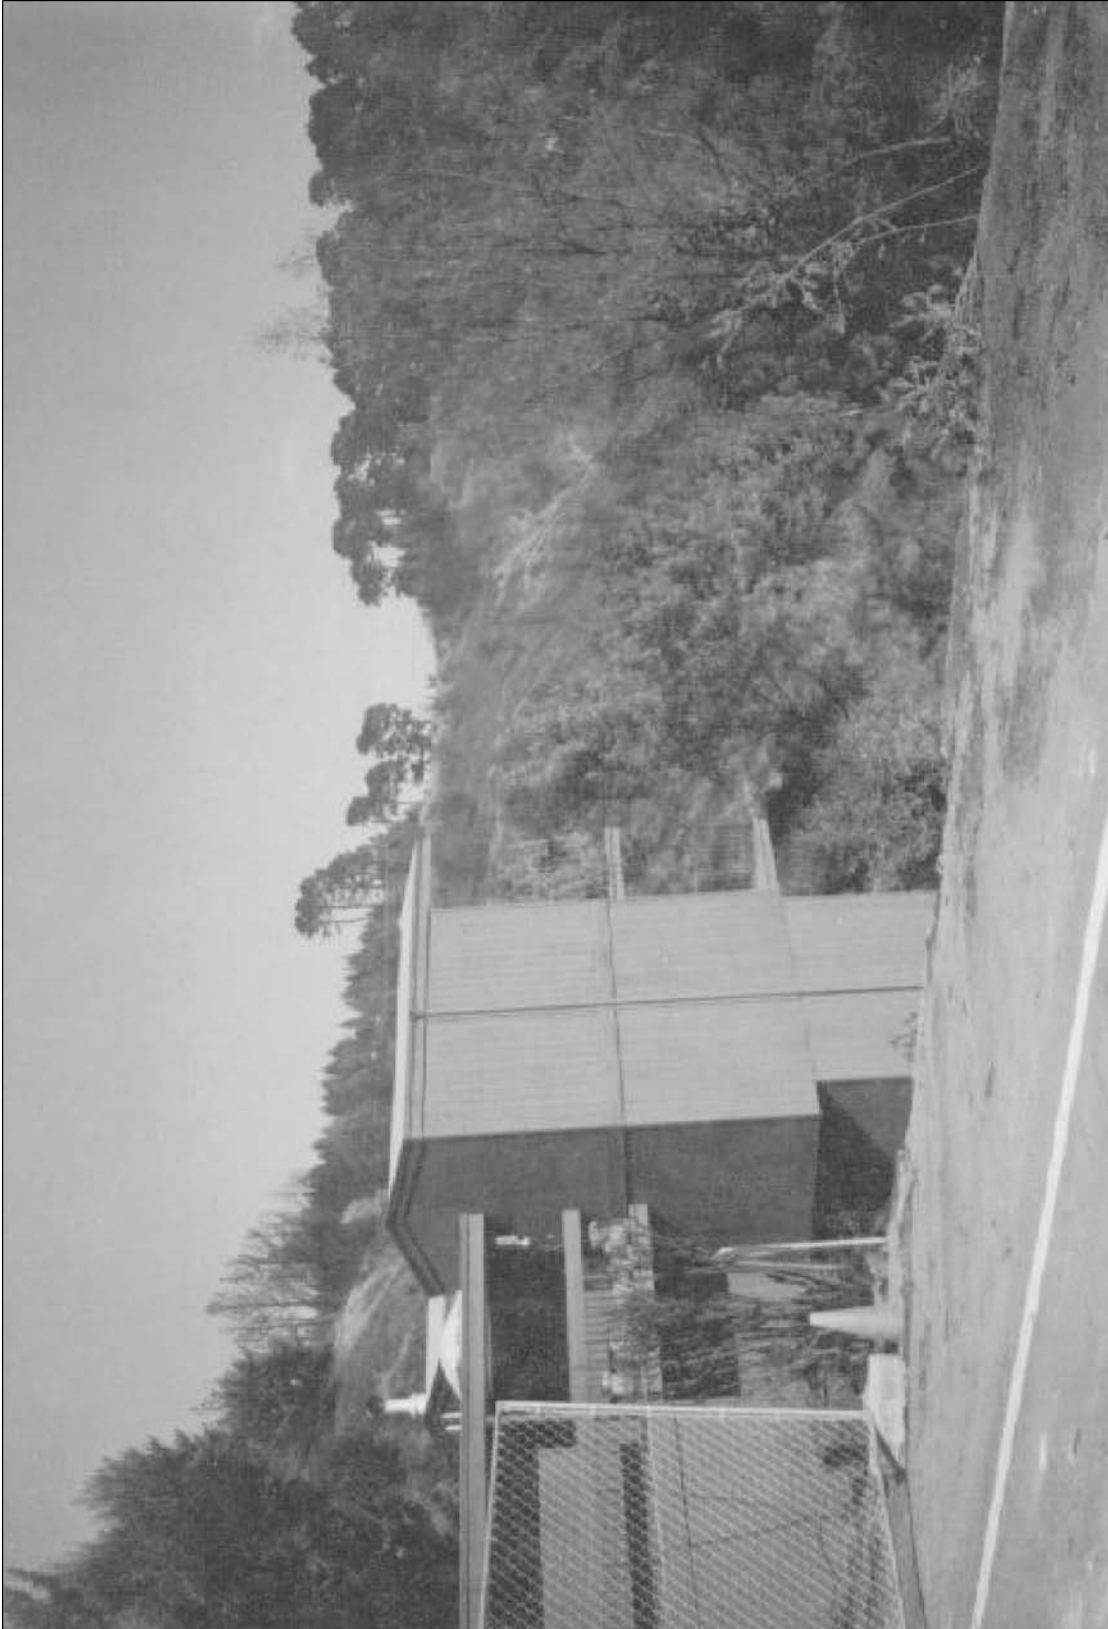
One of the few homes on Marlborough Terrace that was not destroyed by the fire. Houses on both sides burned to the ground.

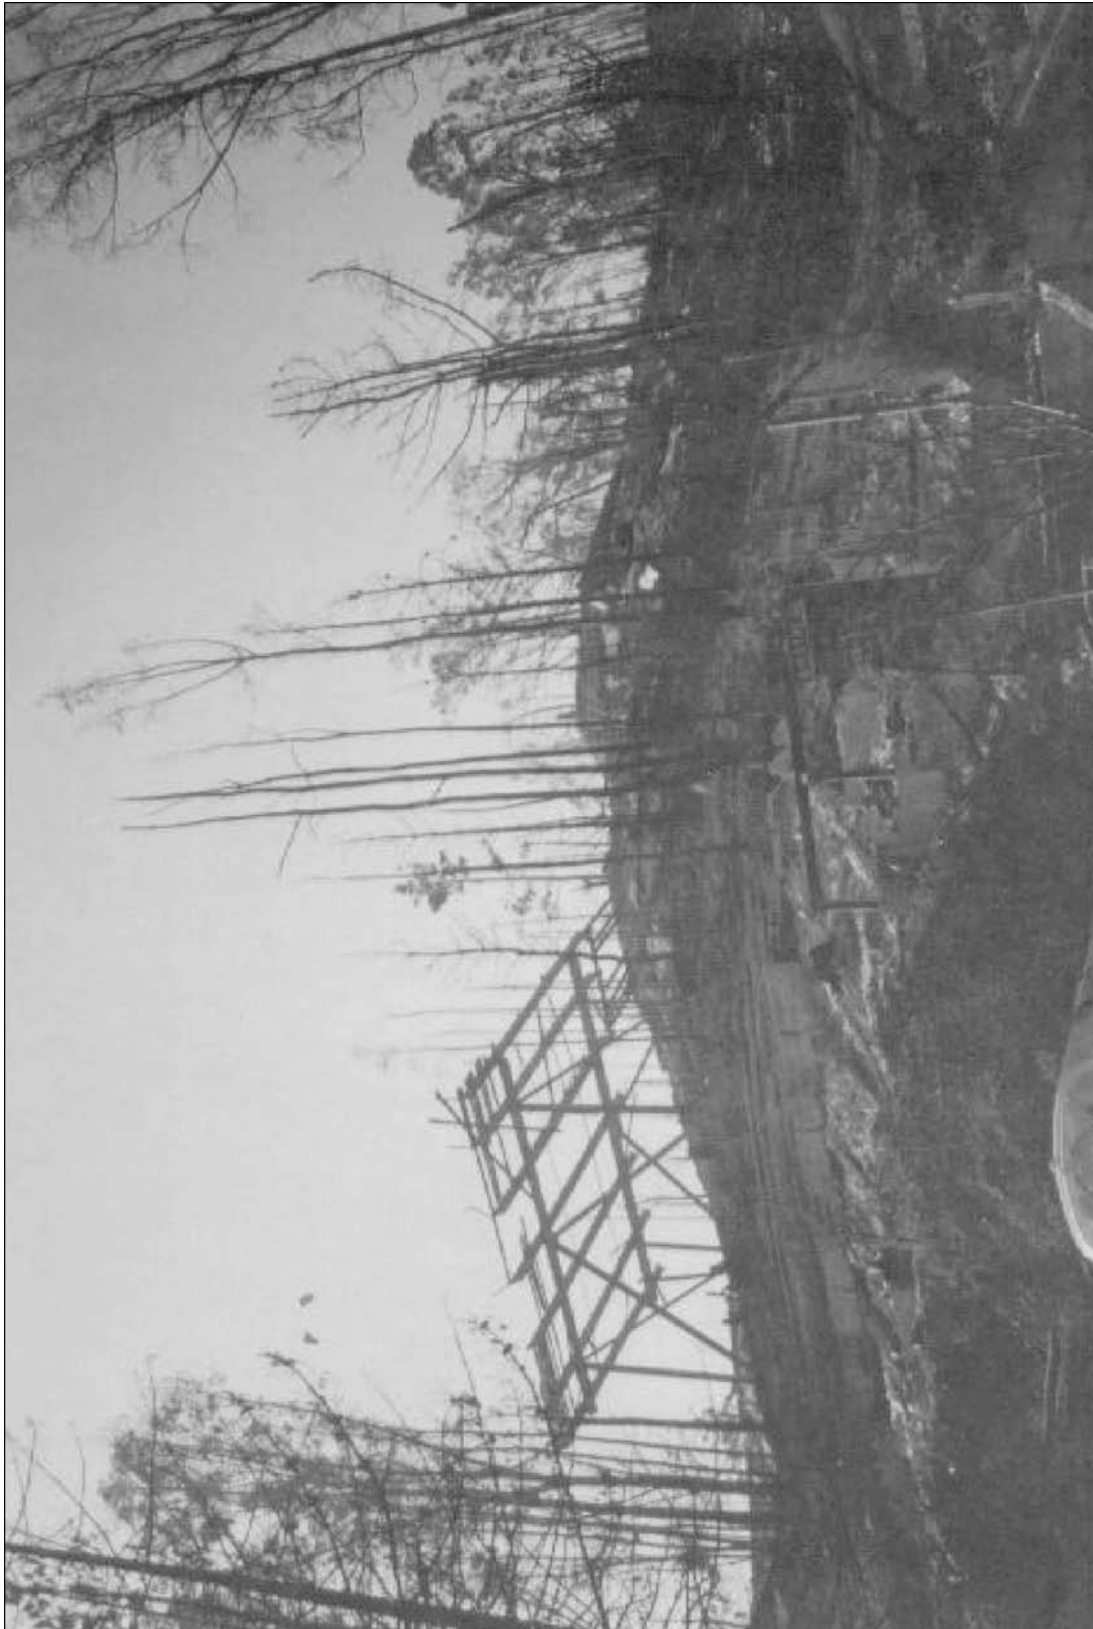
All that remains of one hillside home is the steel supporting structure for the main floor.

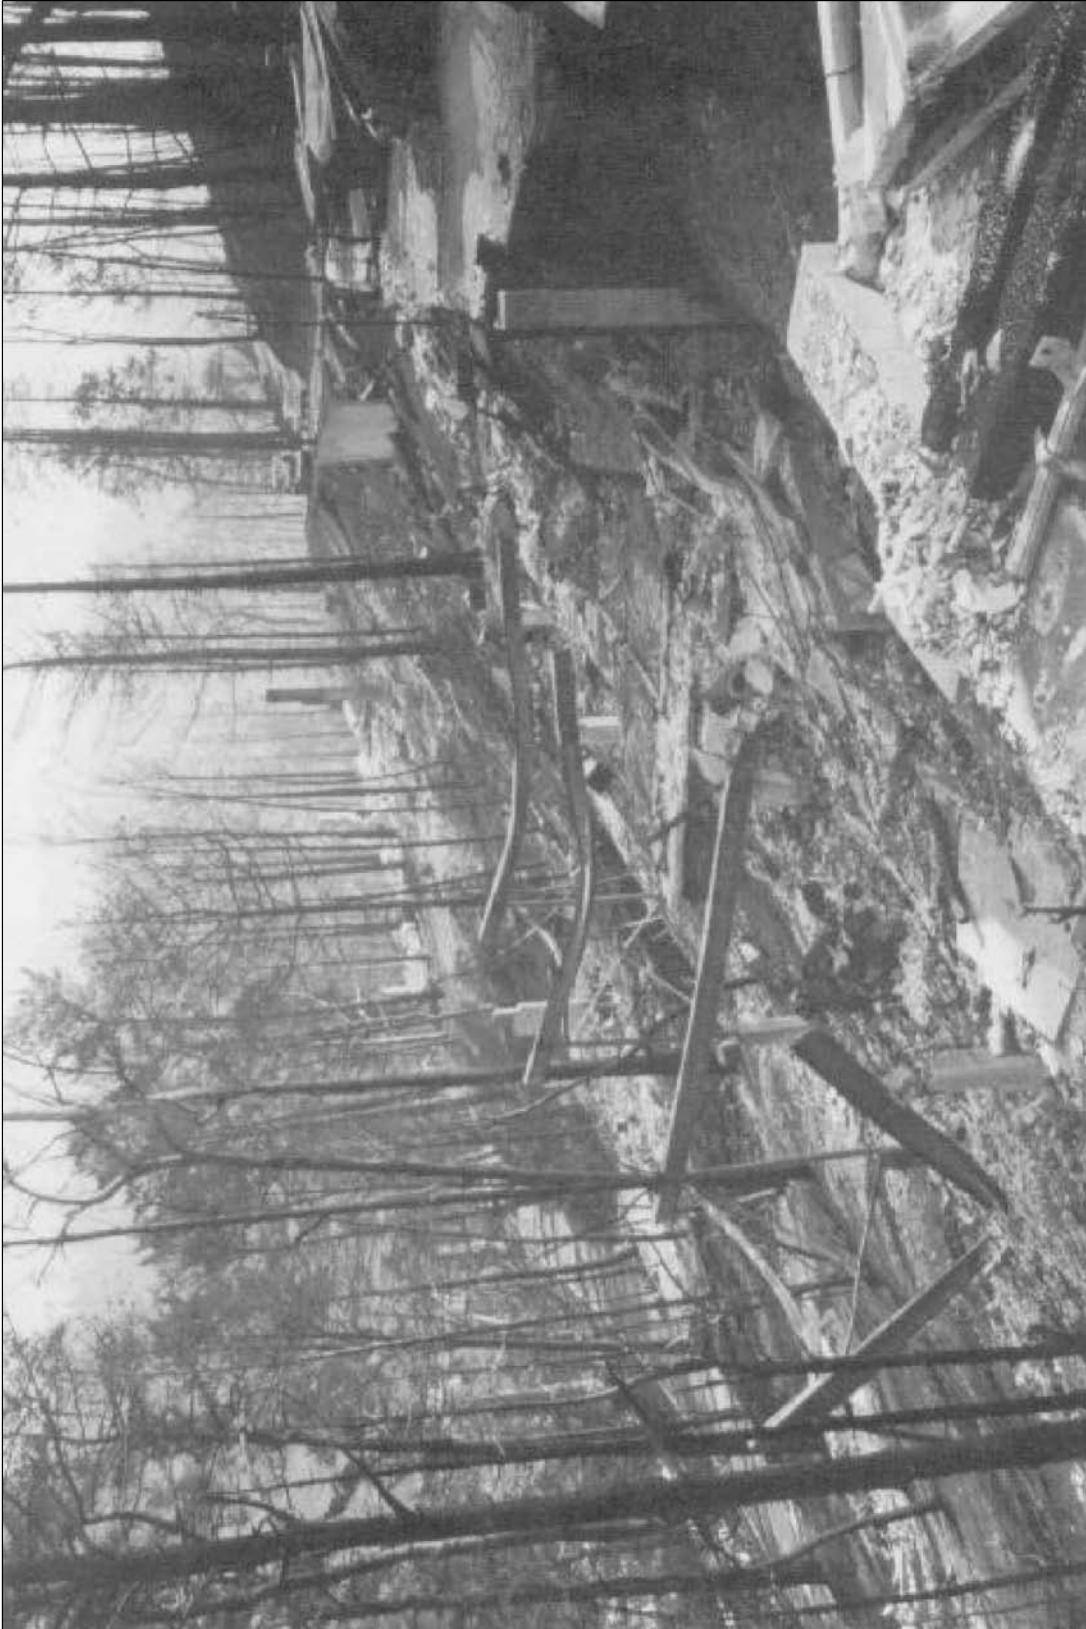
Buckled steel beams mark the location of a destroyed home on Buckingham Boulevard.

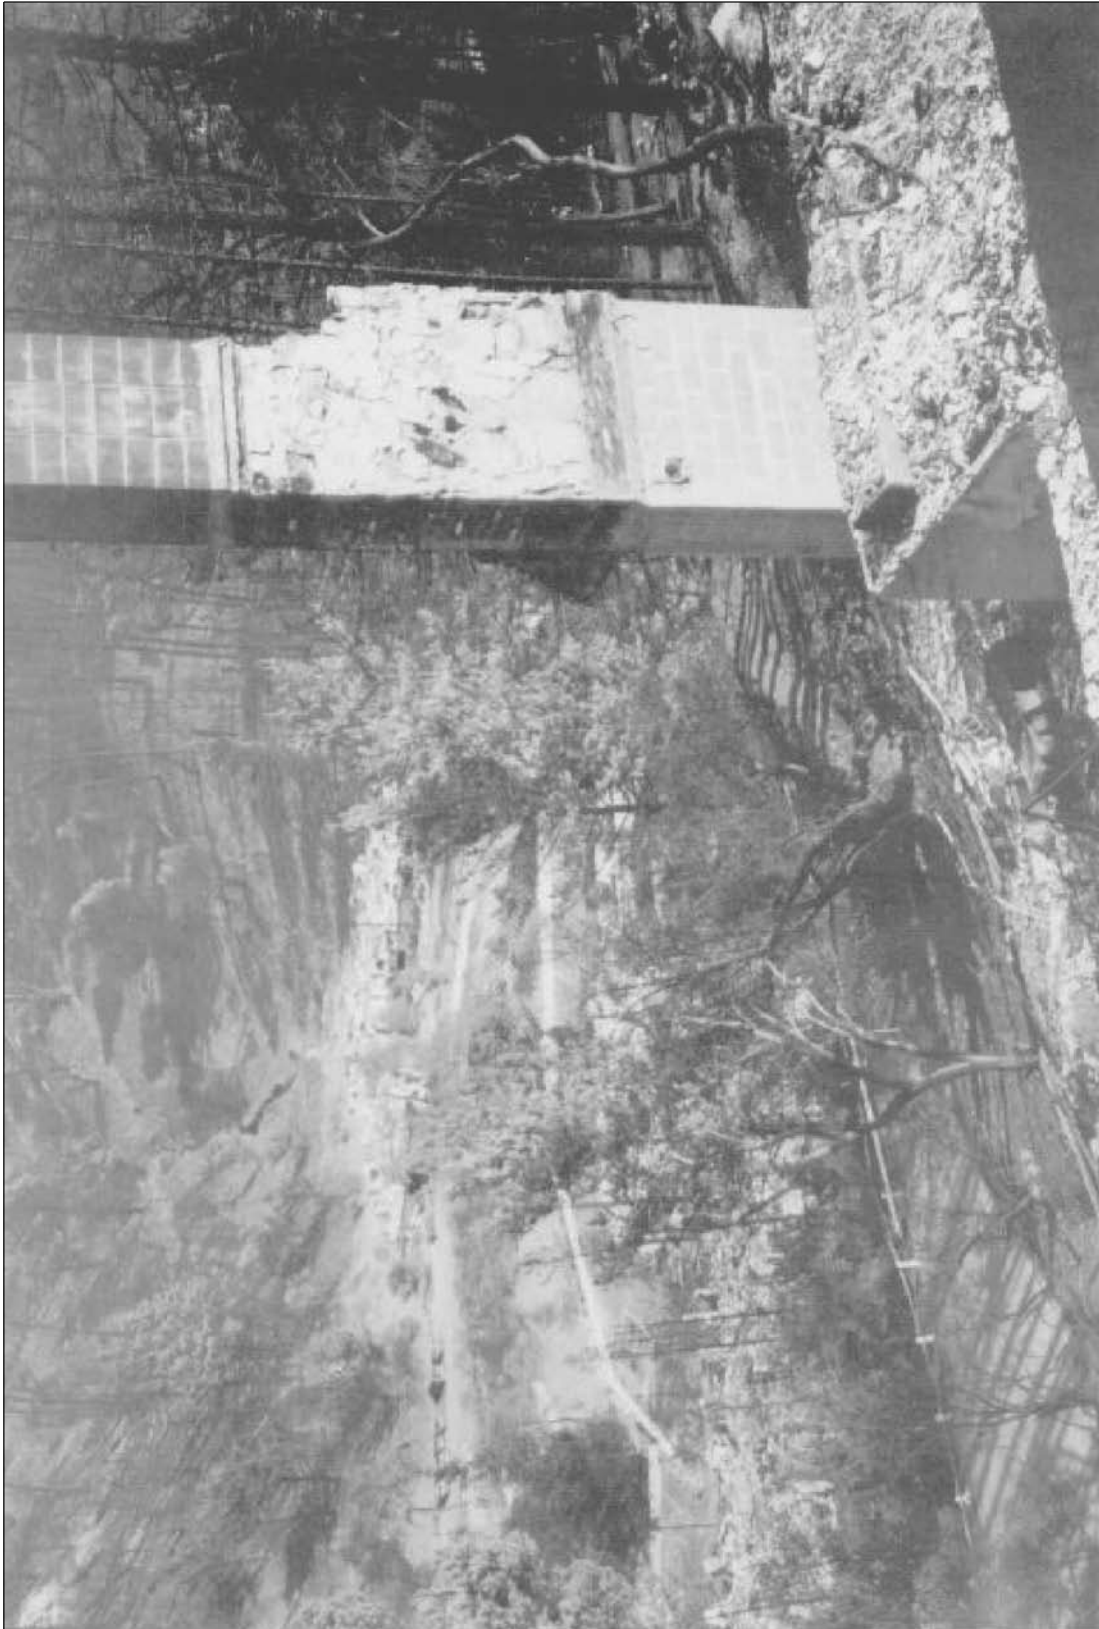
Looking down on the ruins of the Parkwood Apartments from Buckingham Boulevard. Tunnel Road is visible in the lower left corner.

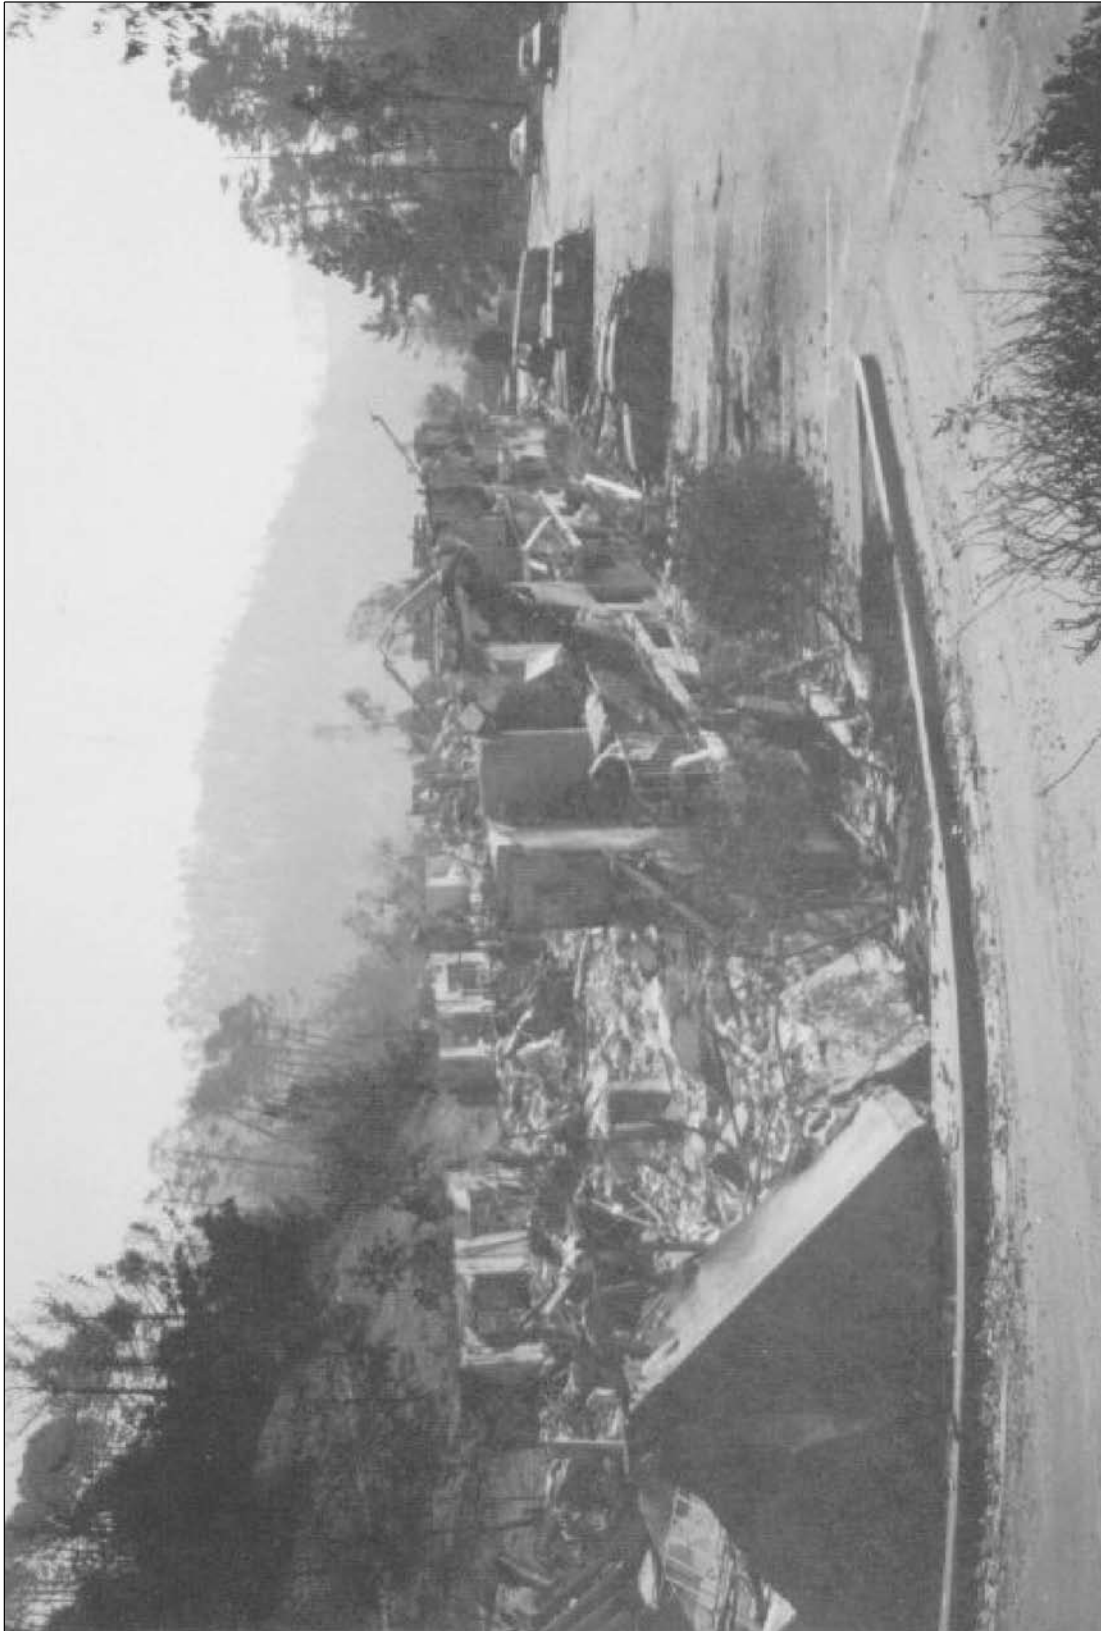
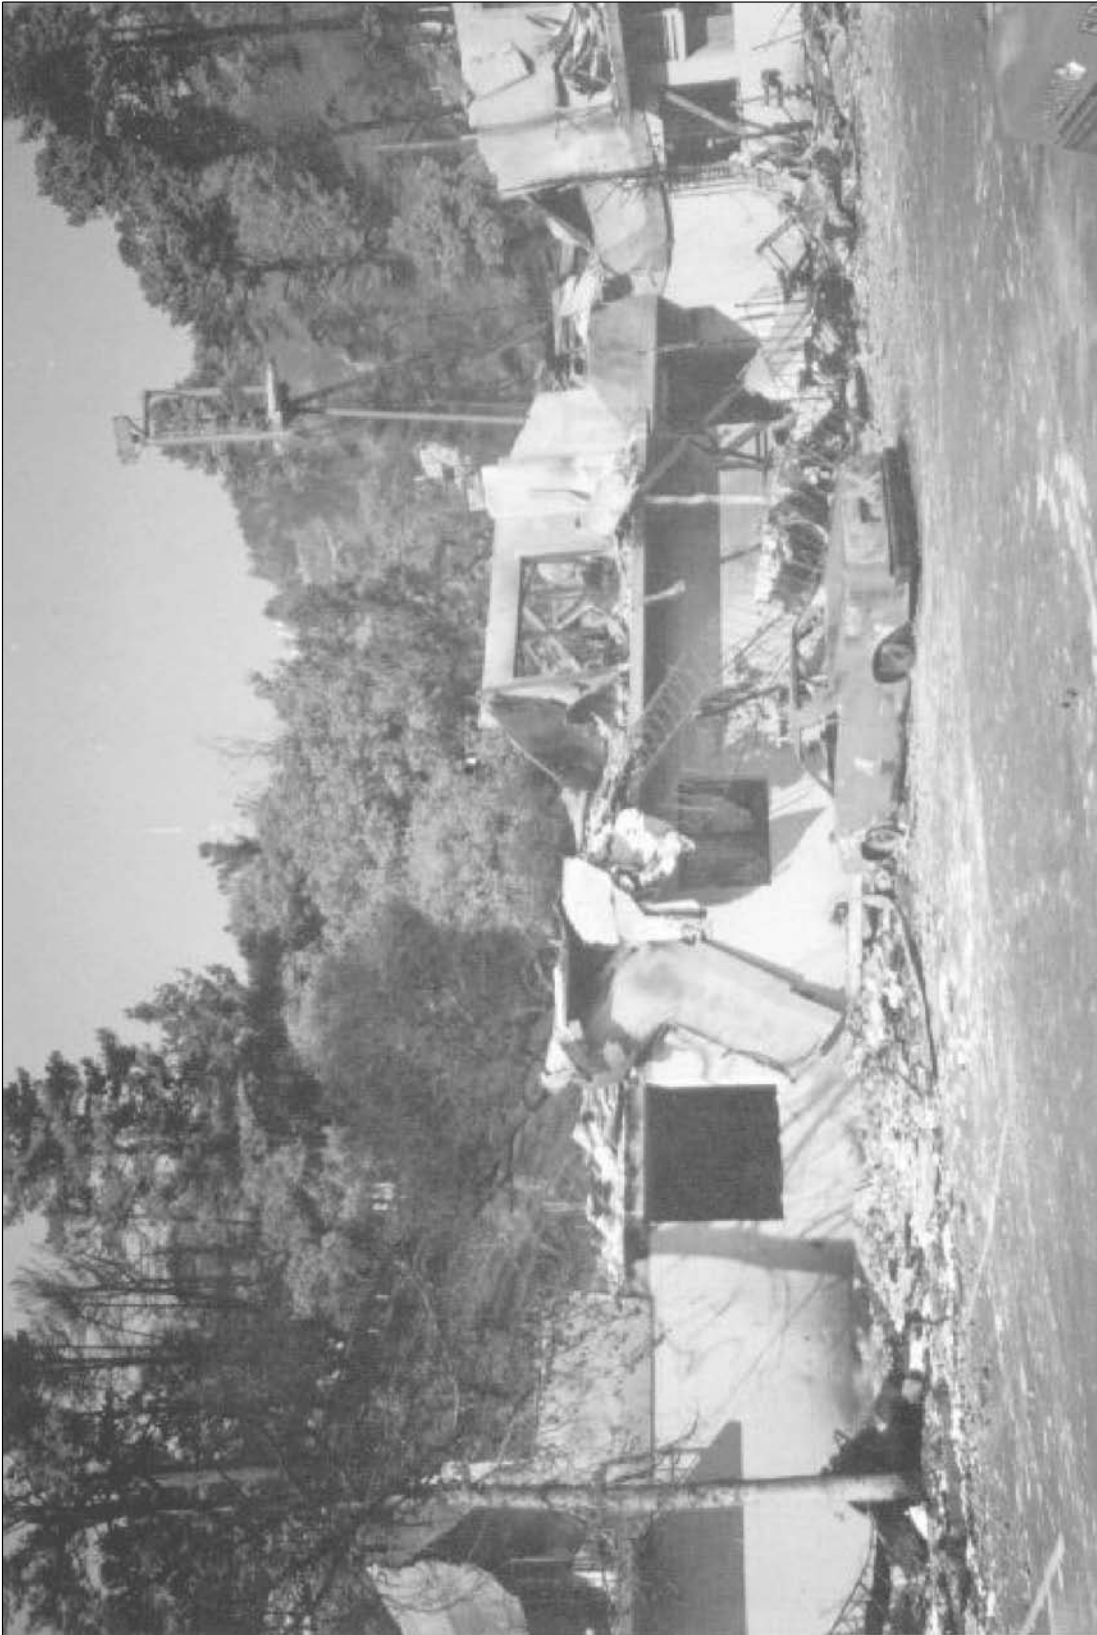
Ruins of the Parkwood Apartments; previously four-story buildings.

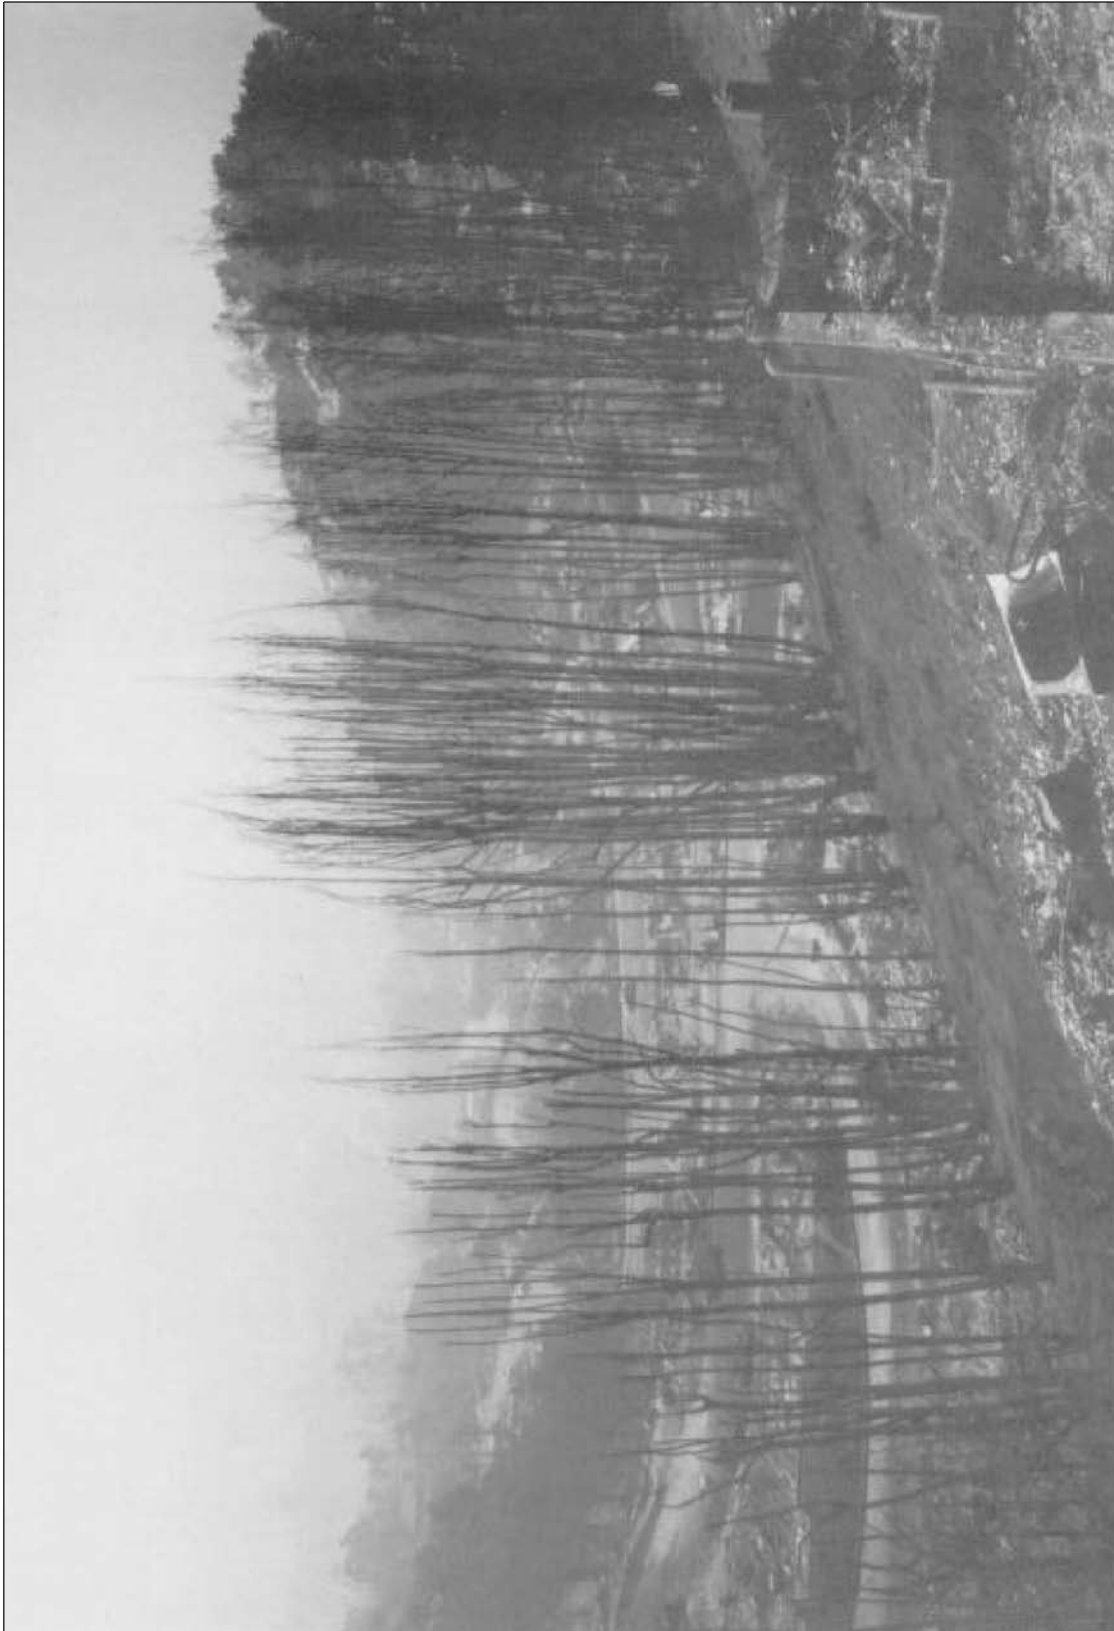
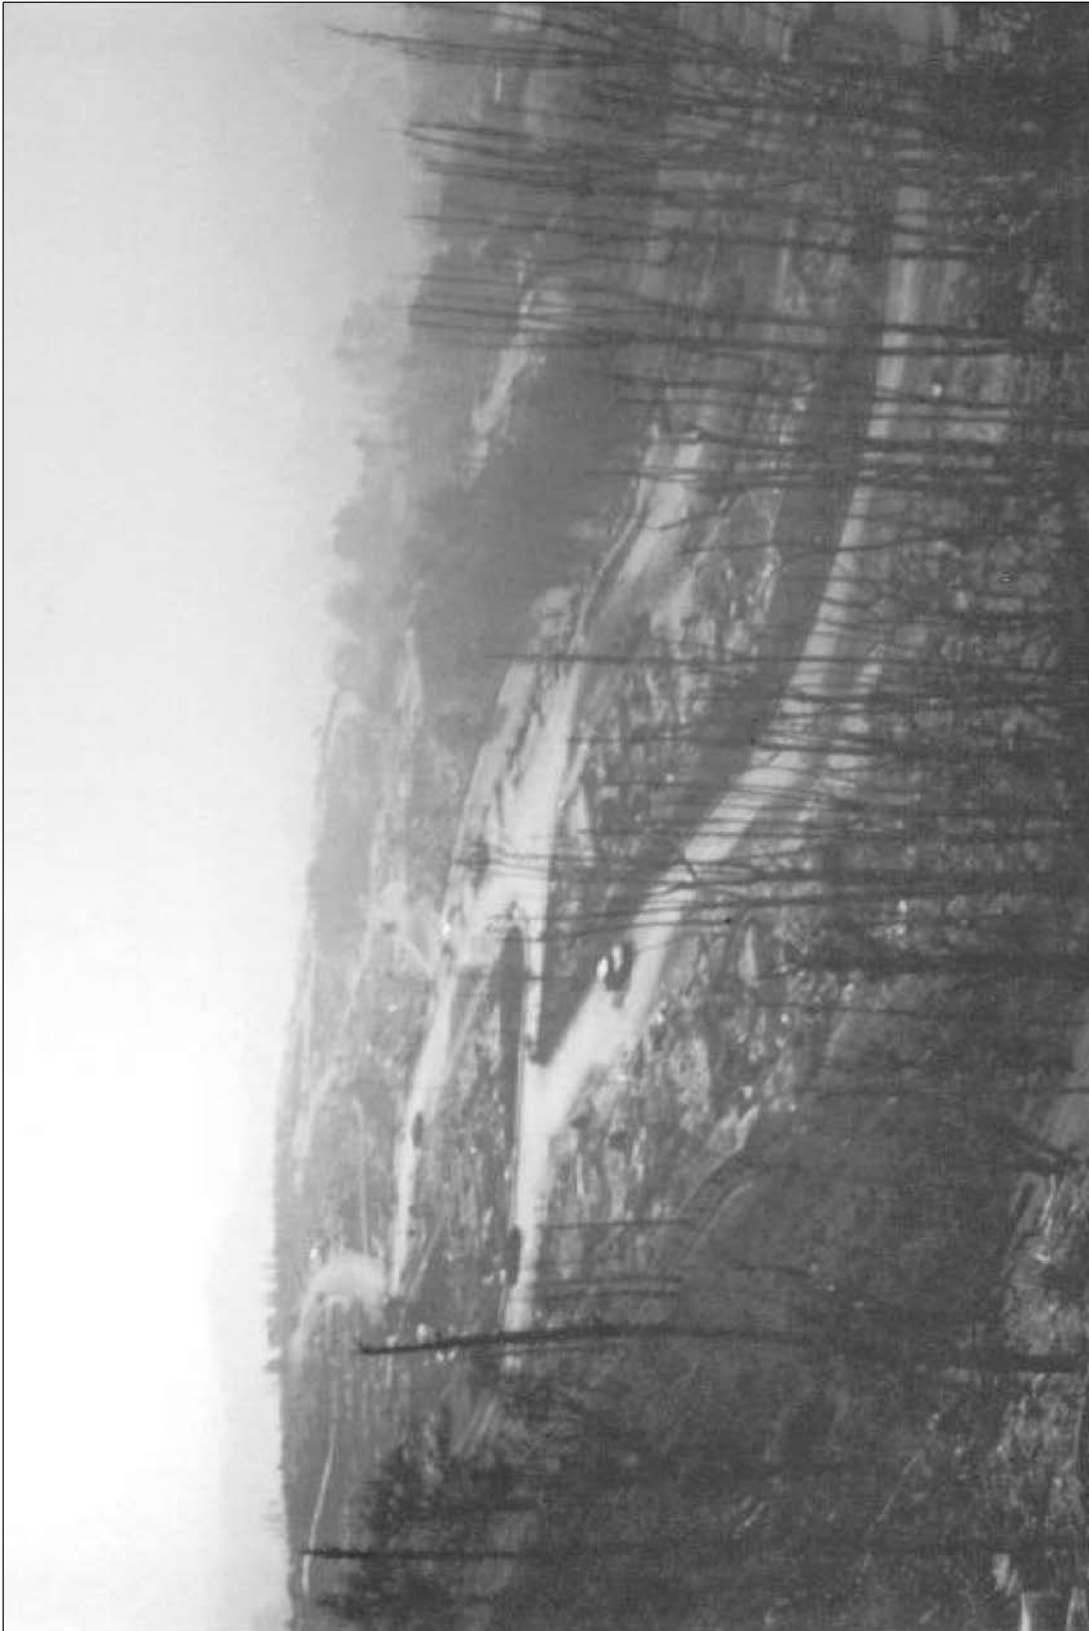
Total destruction of Hiller Highlands complex.

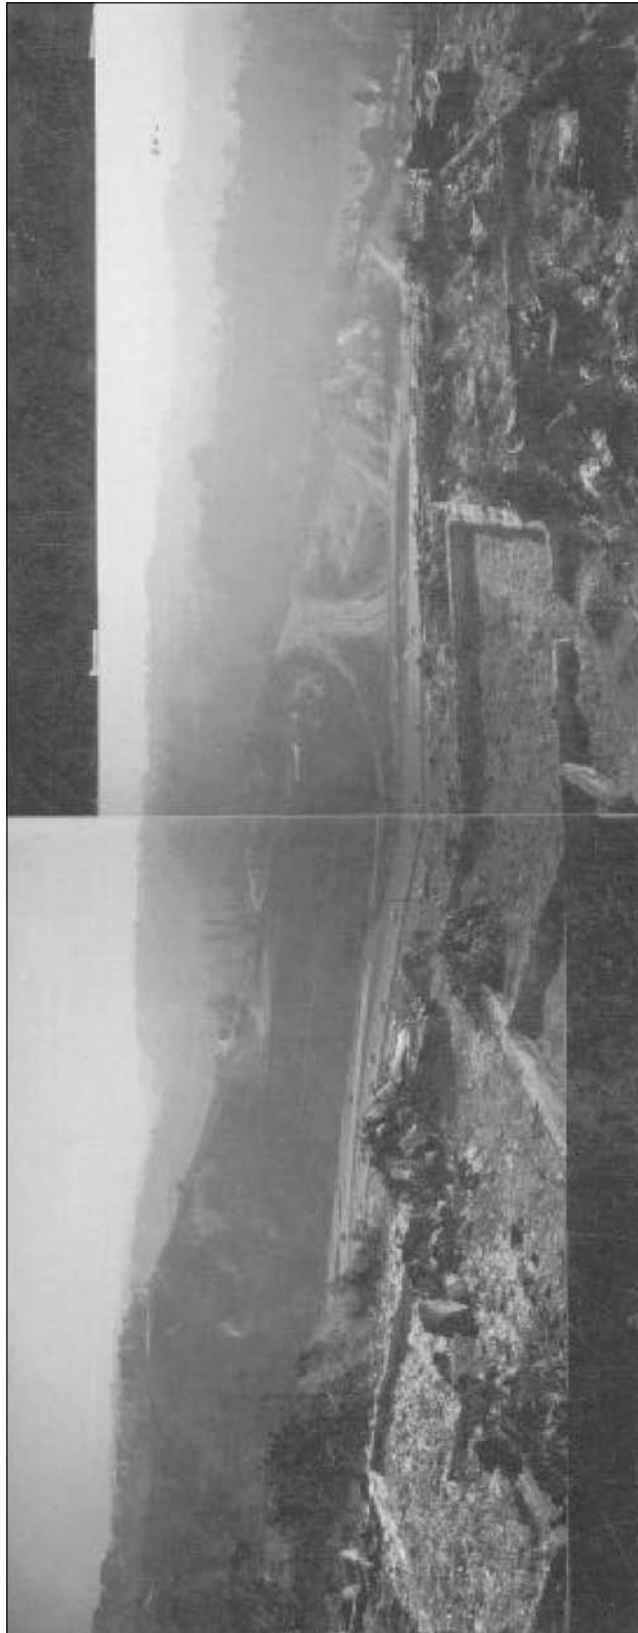
View from Hiller Highlands, looking down on interchange of Highway 24 and Highway 13. Entrance to Caldecott Tunnel is to the left. Lake Temescal and Rockridge District in the background. Fire jumped from Hiller Highlands to the trees beyond Lake Temescal, a distance of approximately 2,000 feet.
