U.S. Fire Administration/Technical Report Series

The East Bay Hills Fire

Oakland-Berkeley, California

USFA-TR-060/October 1991

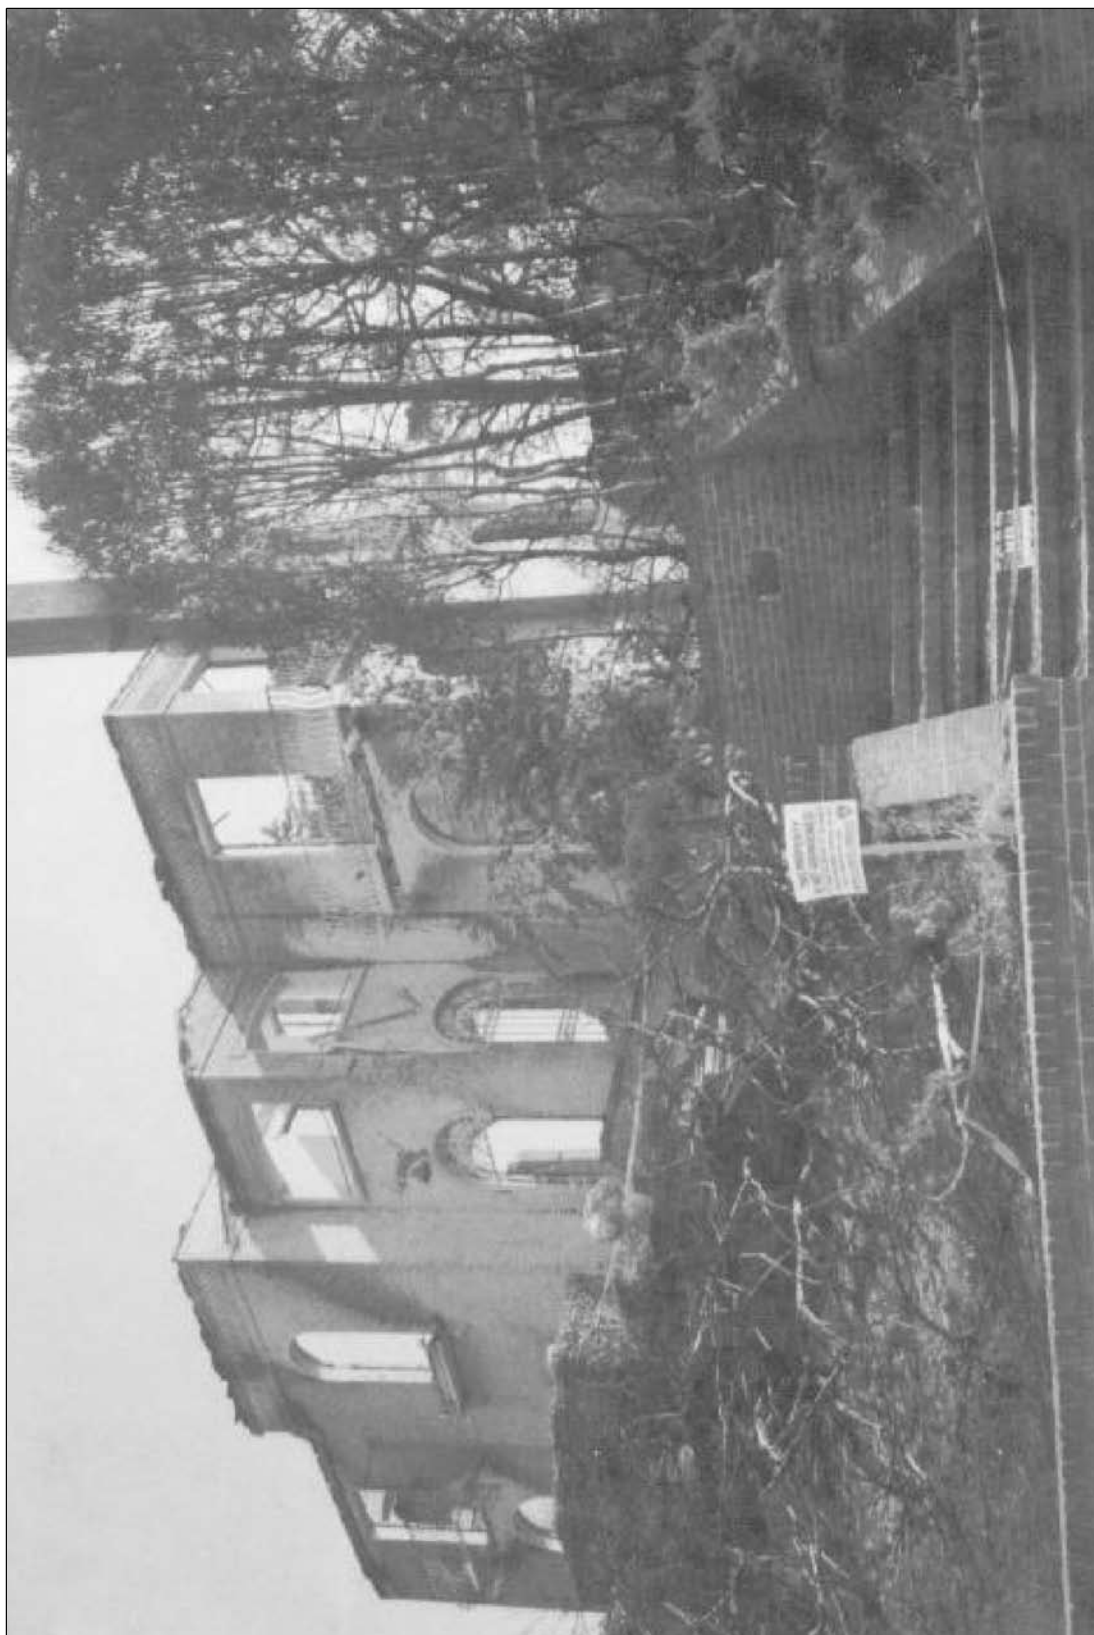
Ruins of large two-story home in Rockridge district.

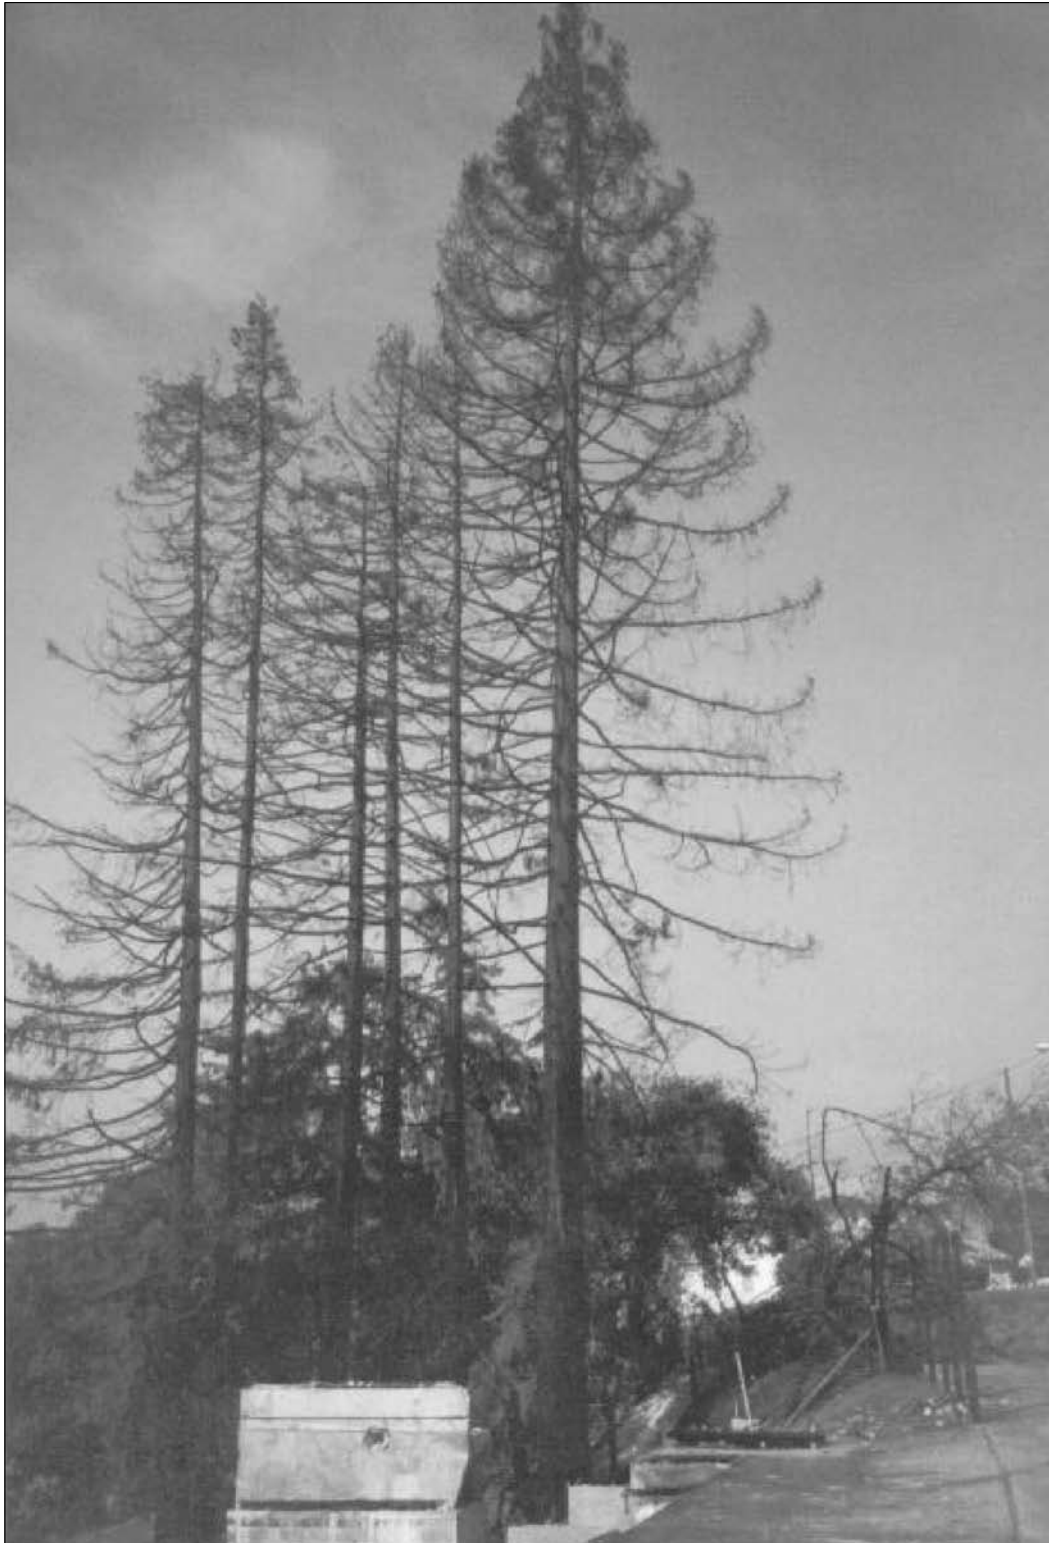
Huge pine trees in the Rockridge district ignited and accelerated the fire spread in this area.

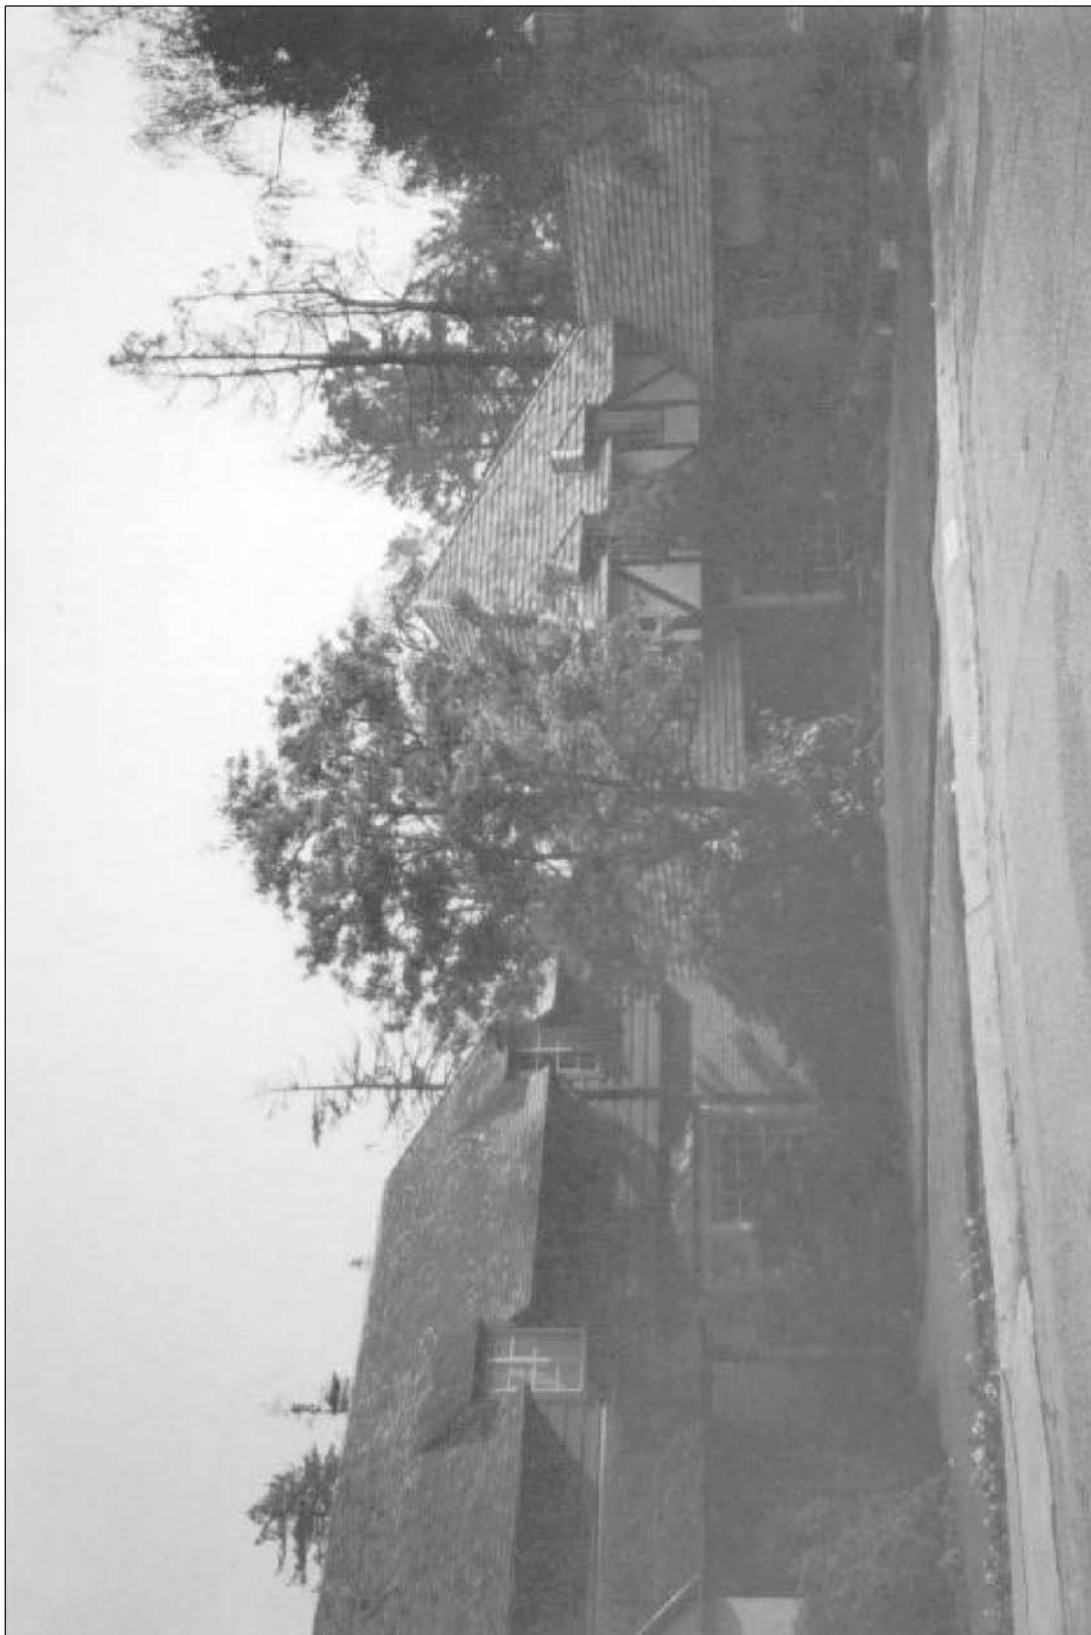
Examples of development in the fire area – wood shingle roofs.

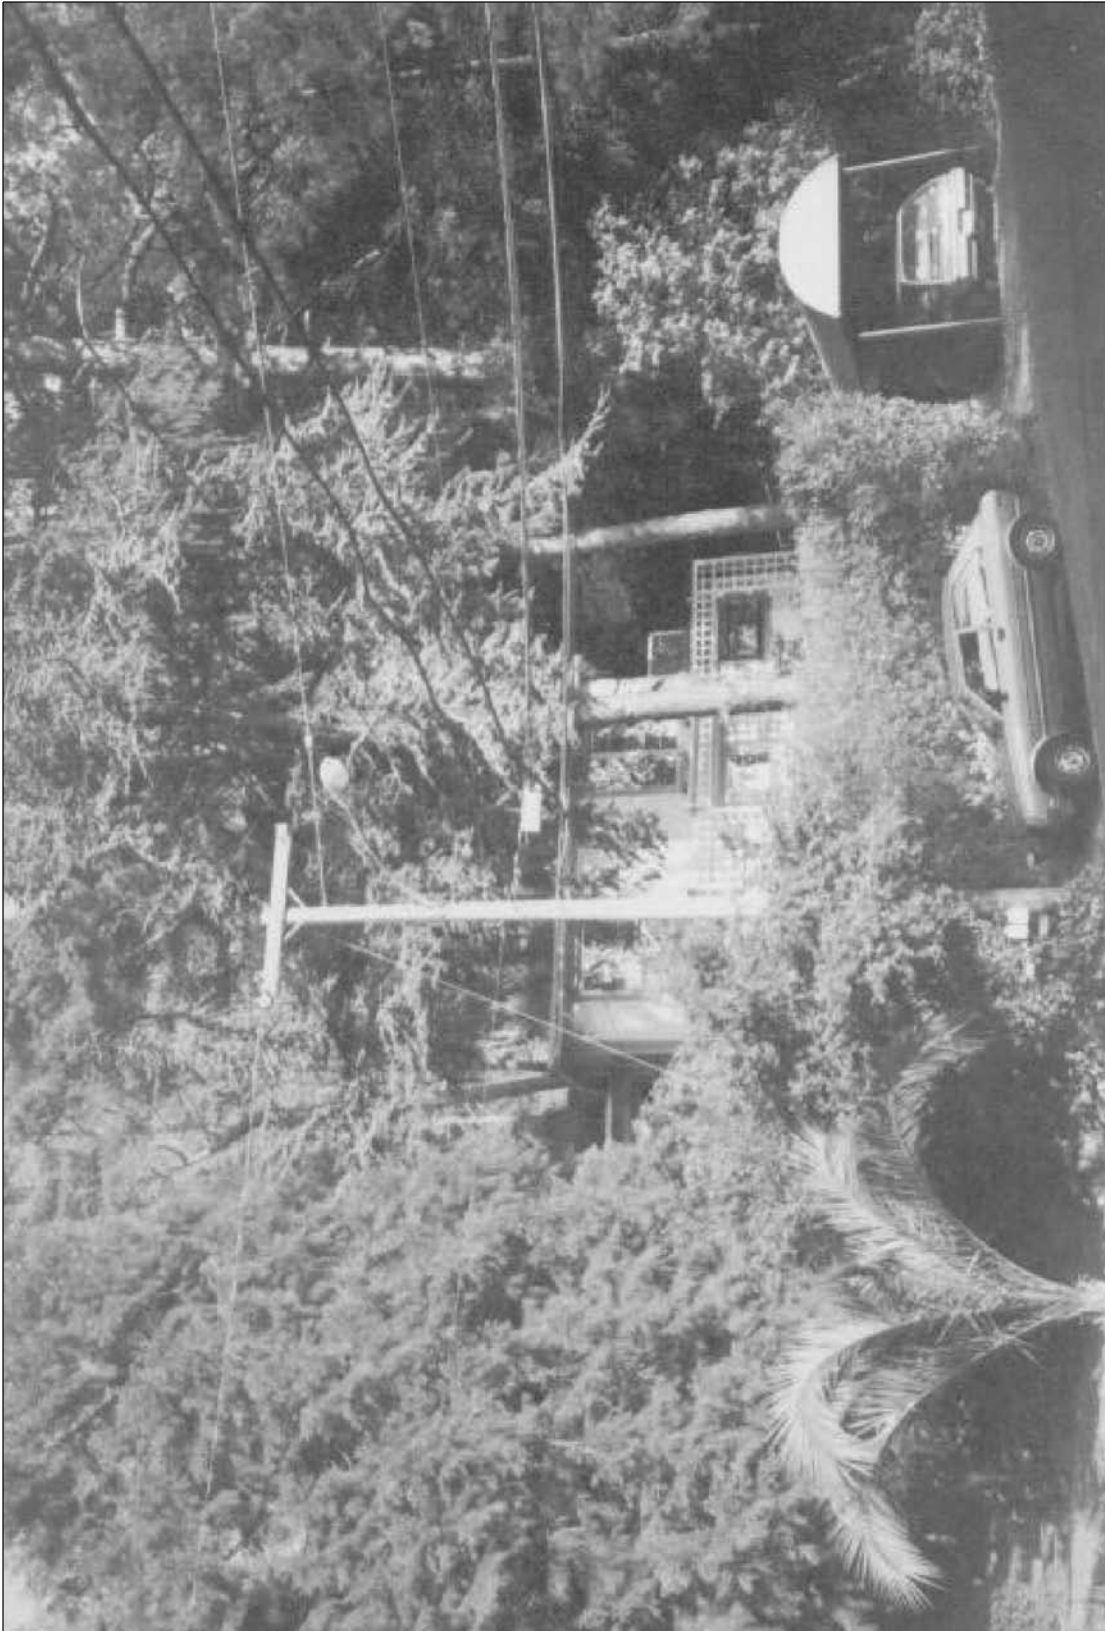
Home enveloped in natural vegetation.

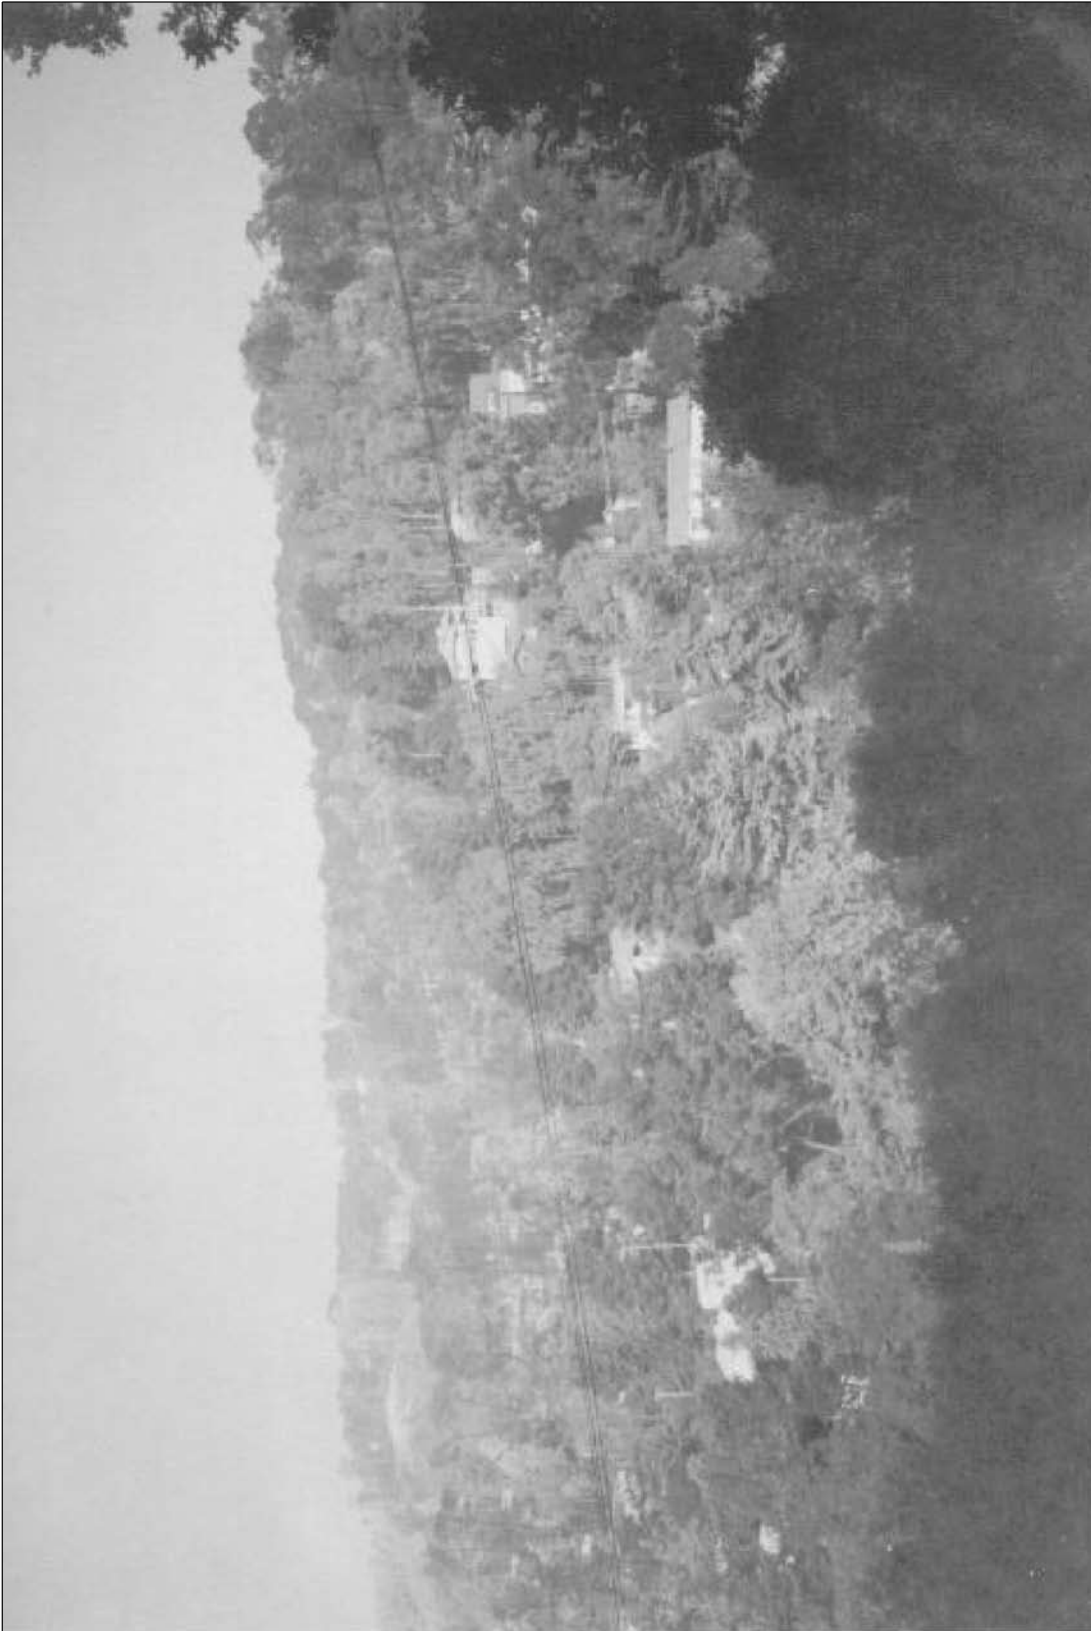
Homes enveloped in natural vegetation – fire area in background.

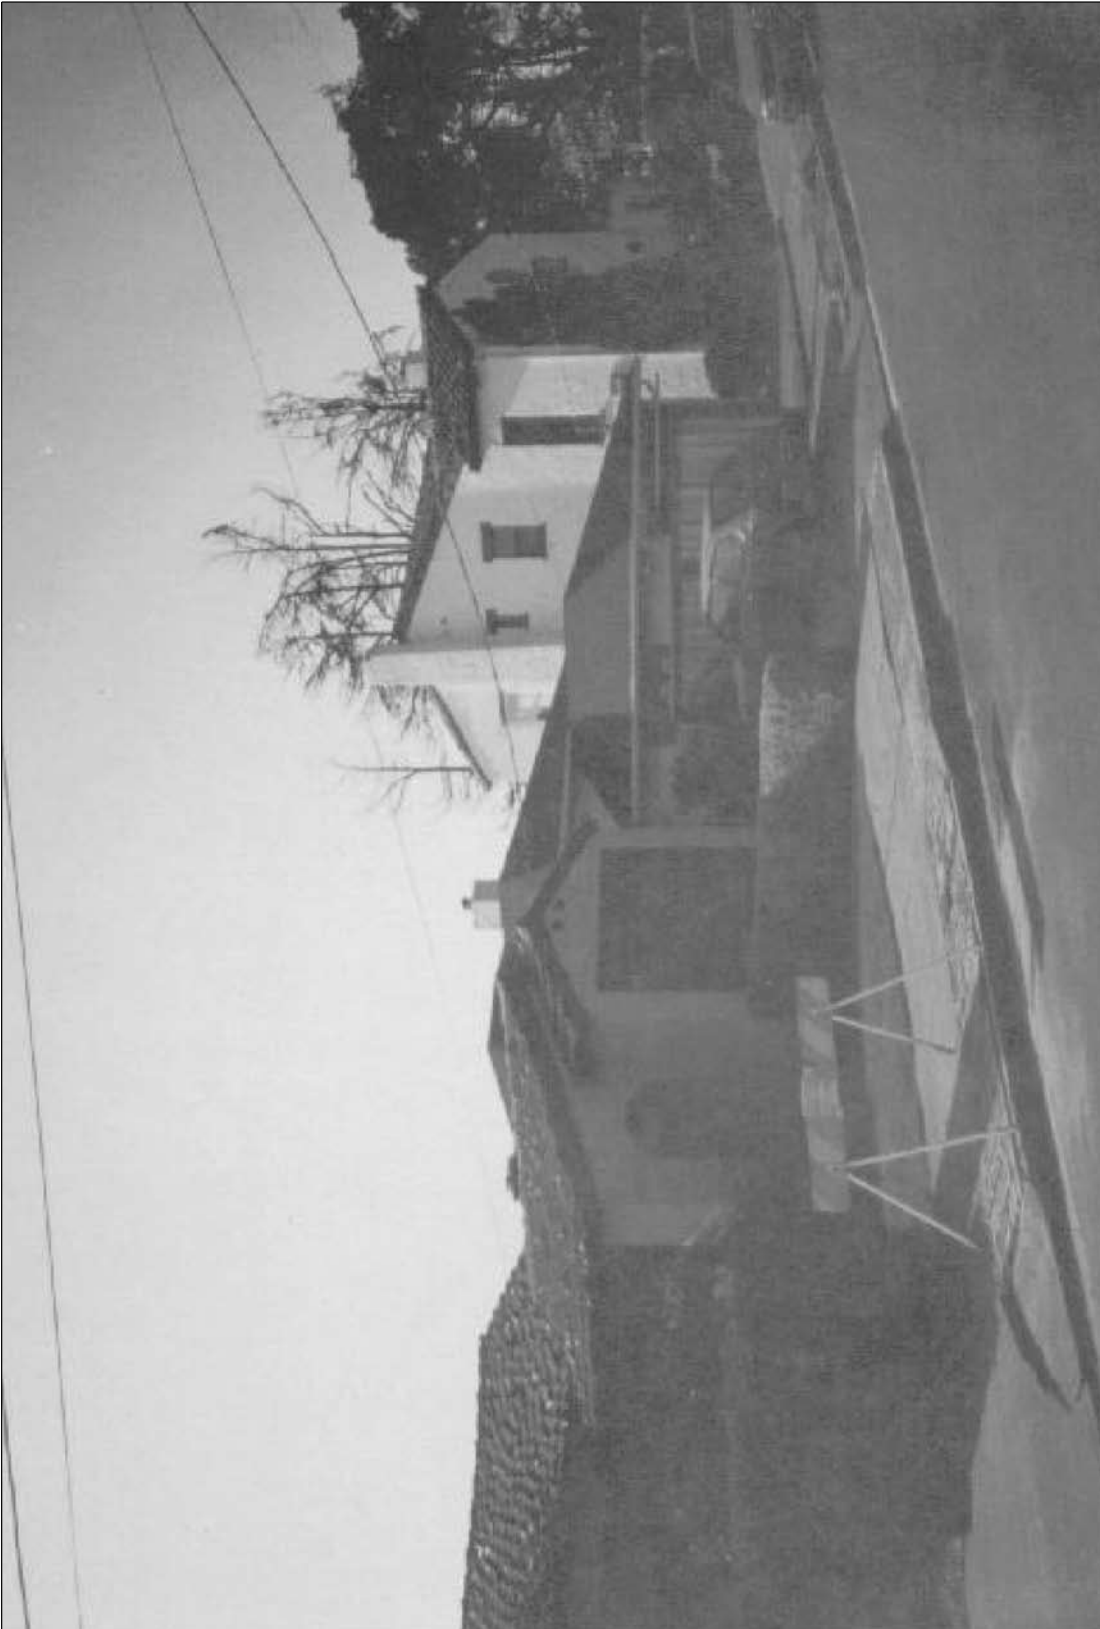
Homes saved within fire area – note non-combustible roofs.

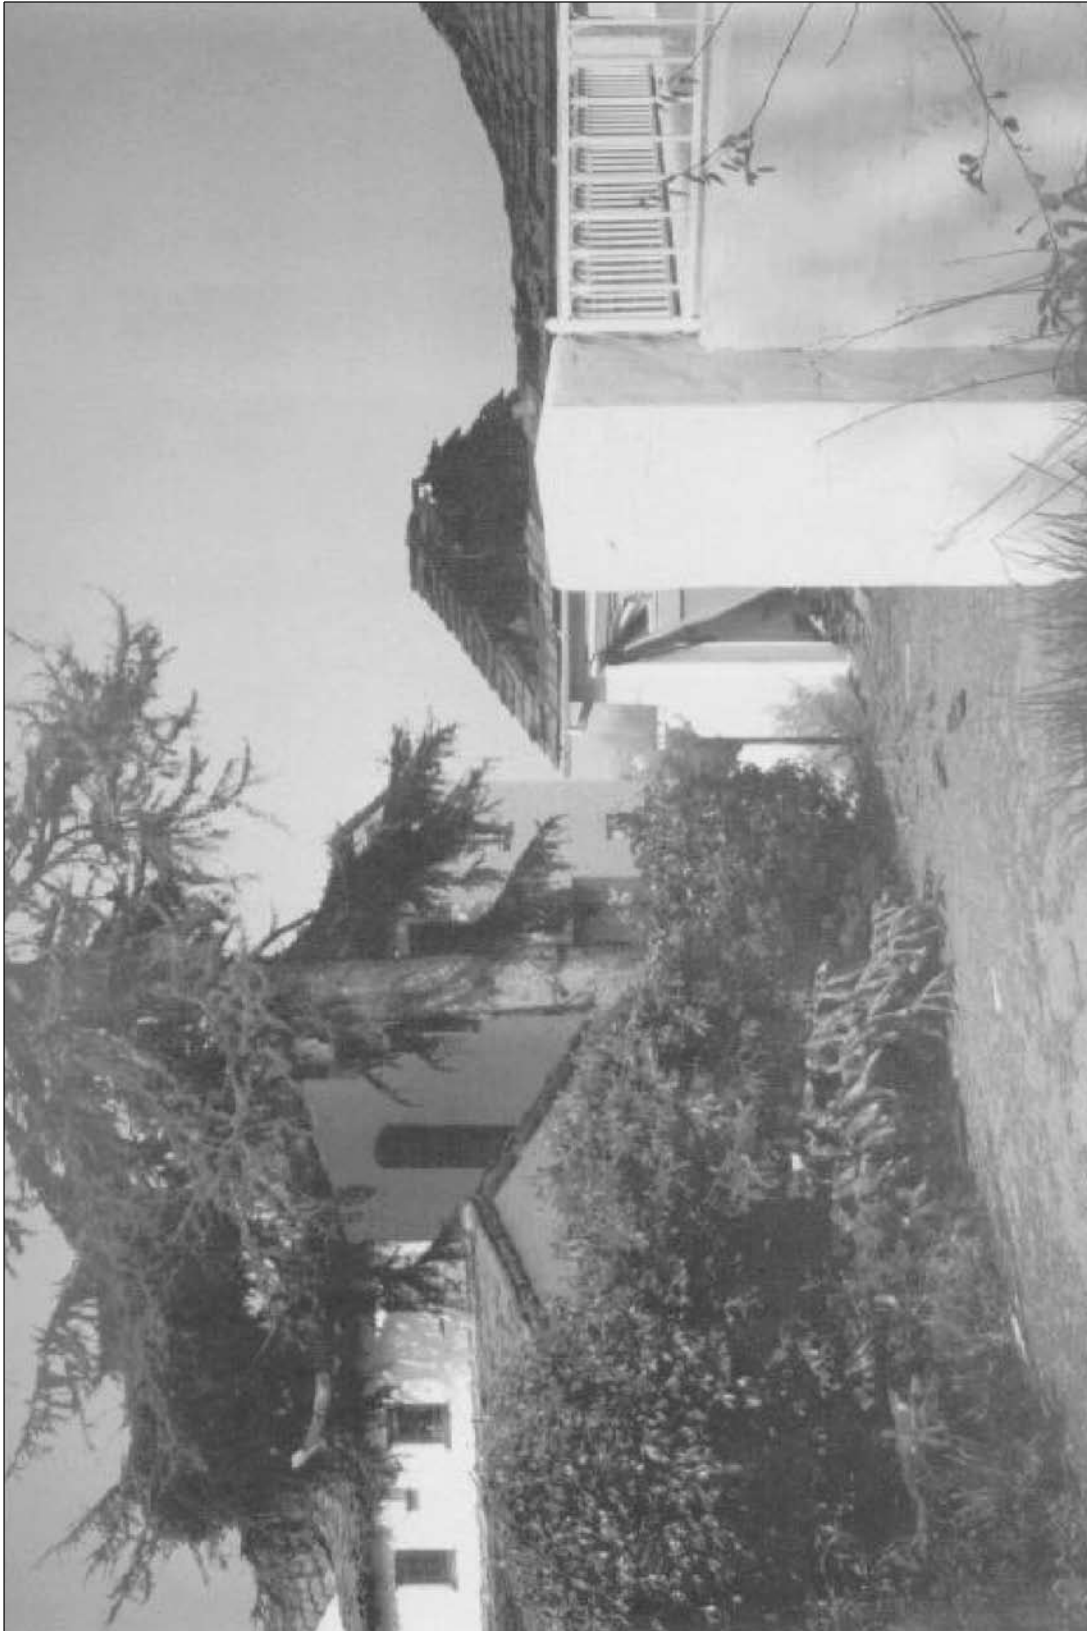
Home with wood shingle roof destroyed. Neighboring home with tile roof saved.

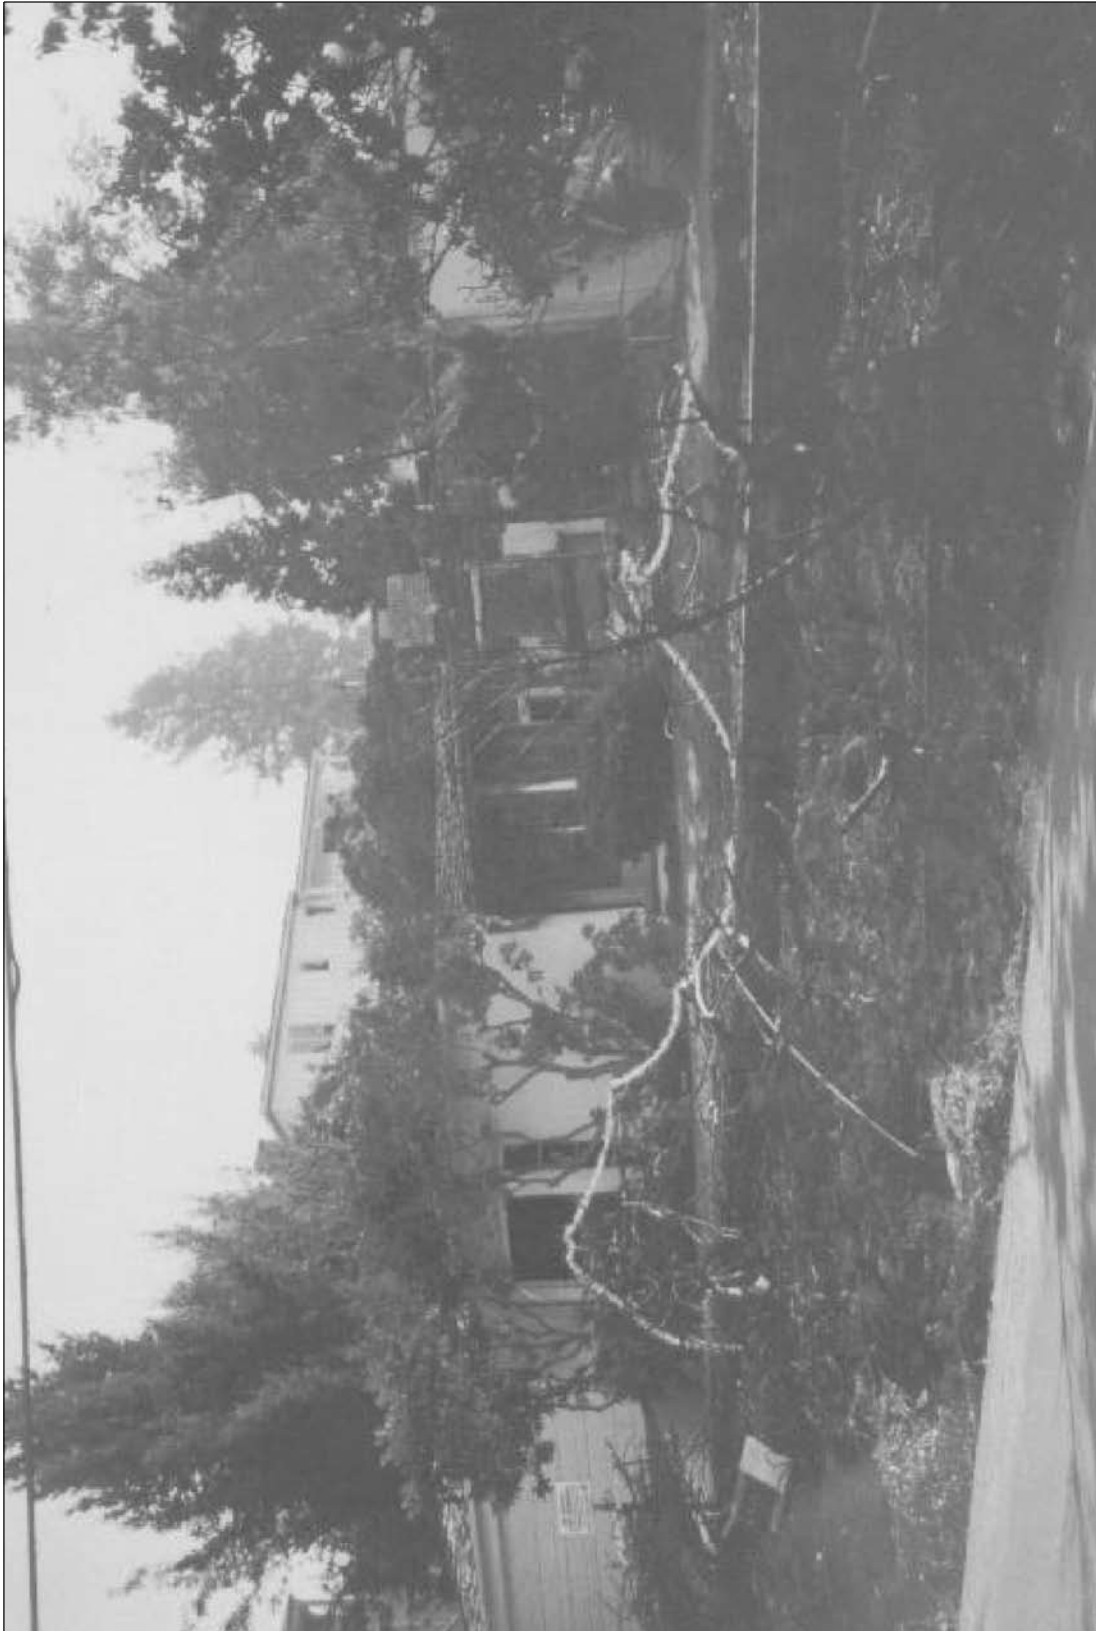
Home with wood roof burned off.

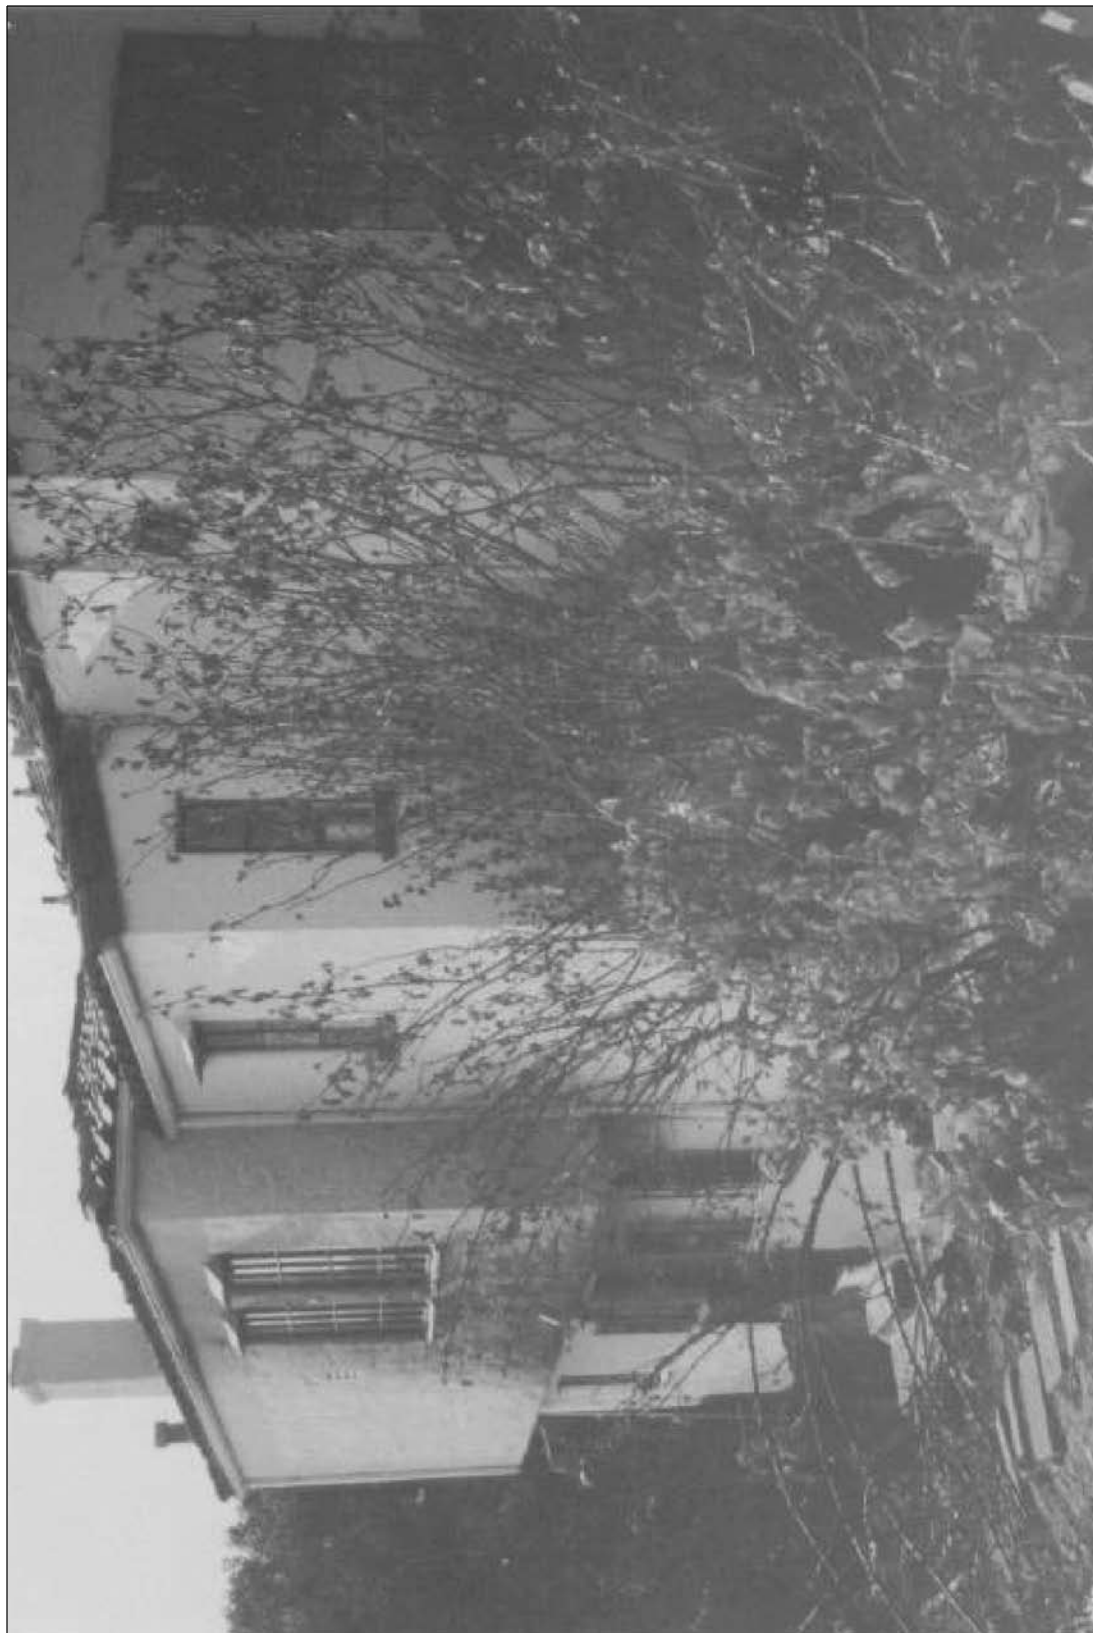
Large home saved by firefighters after vegetation became involved.

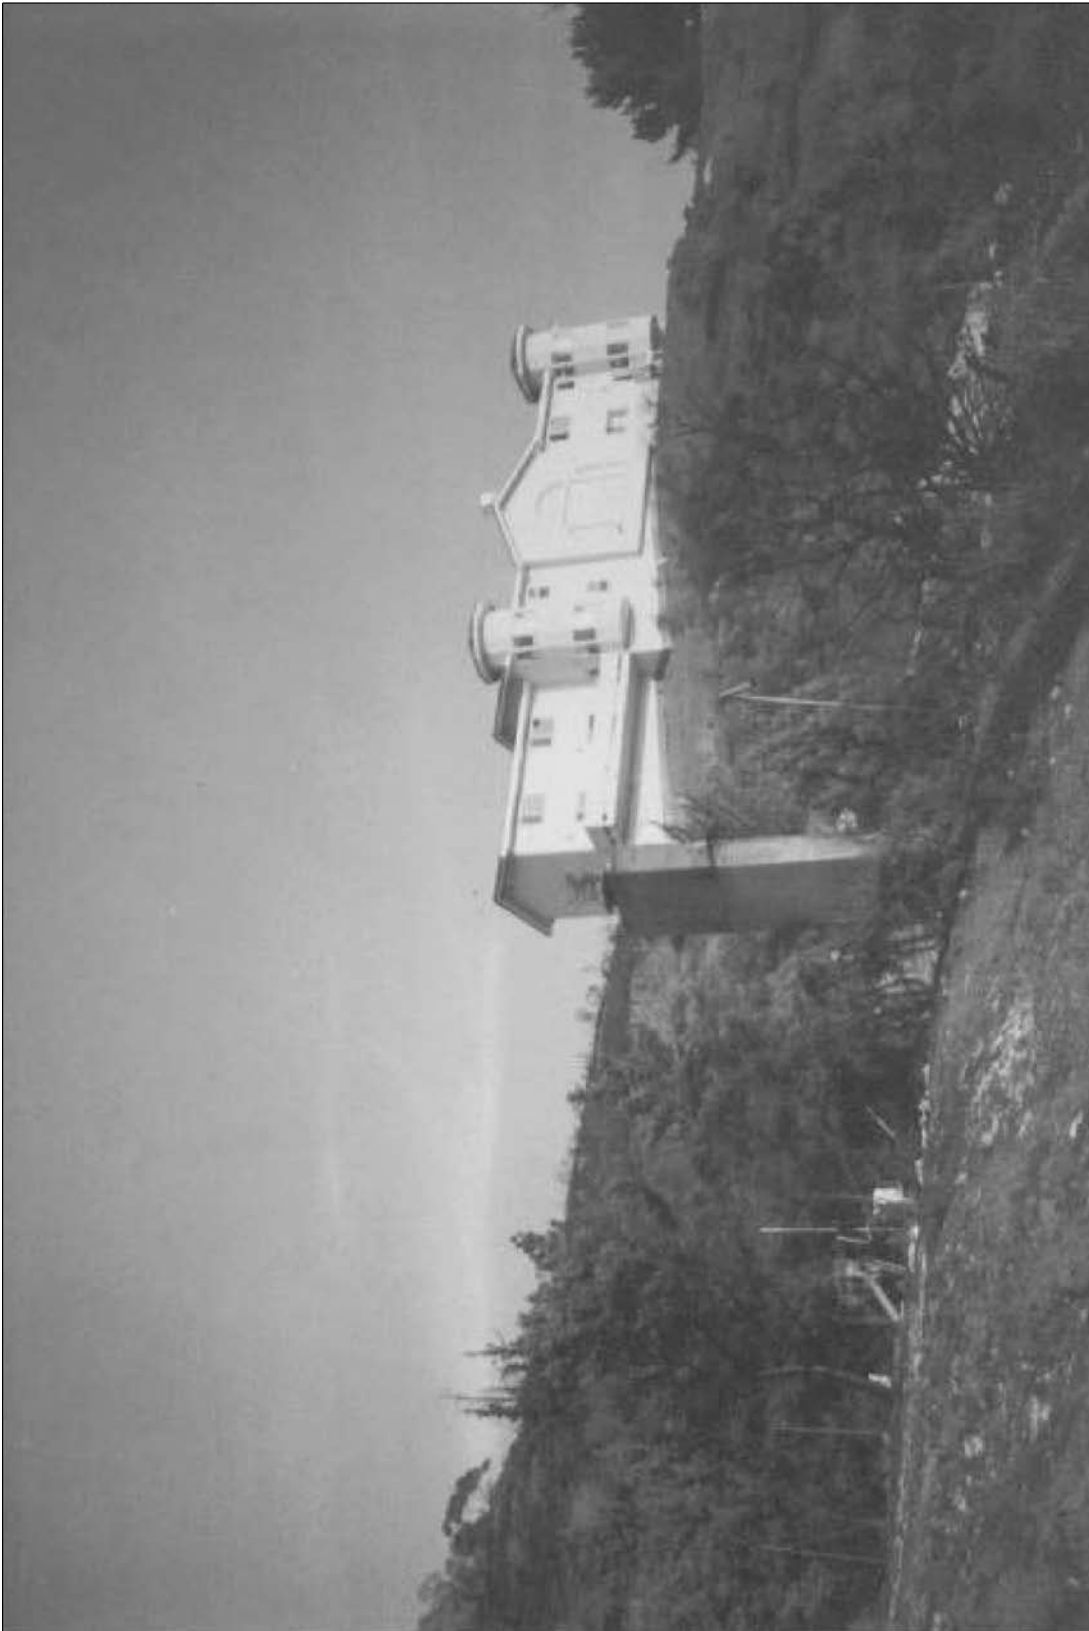
Large home saved by clear area around structure.

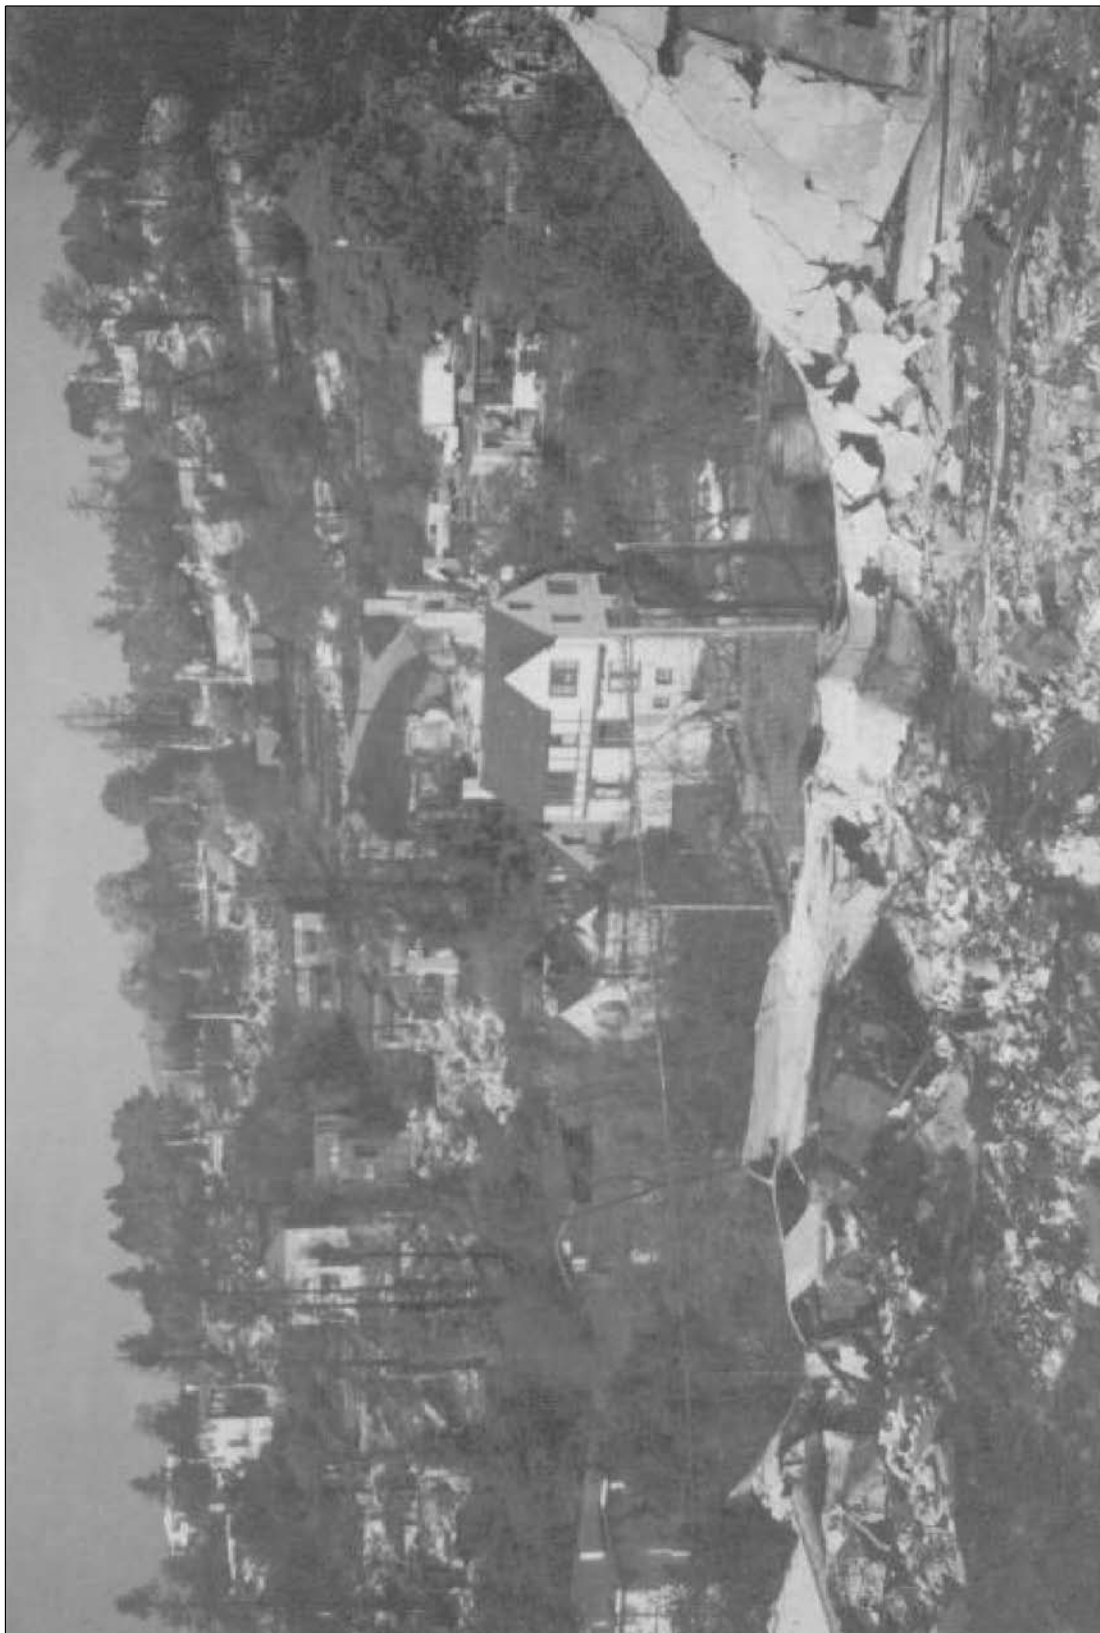
West limits of fire area – groups of homes saved, others lost.

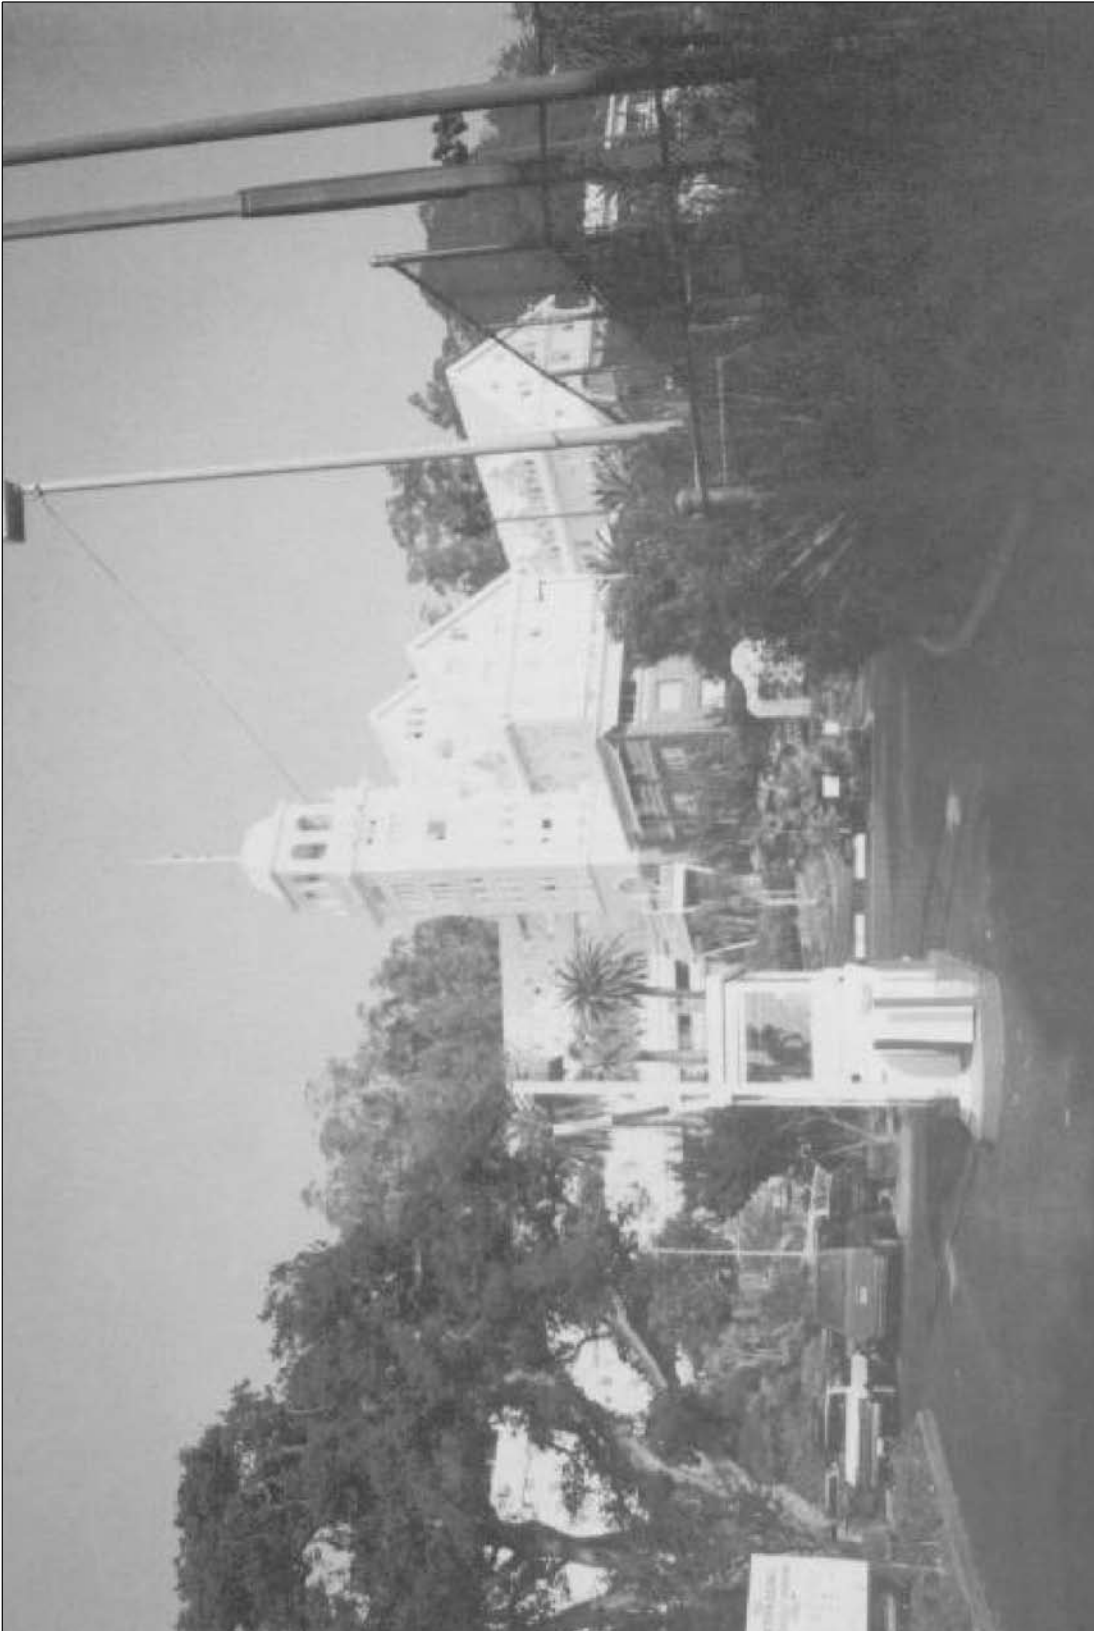
The Claremont Hotel – Five-story wood frame structure in the path of the fire, considered a “conflagration breeder.”

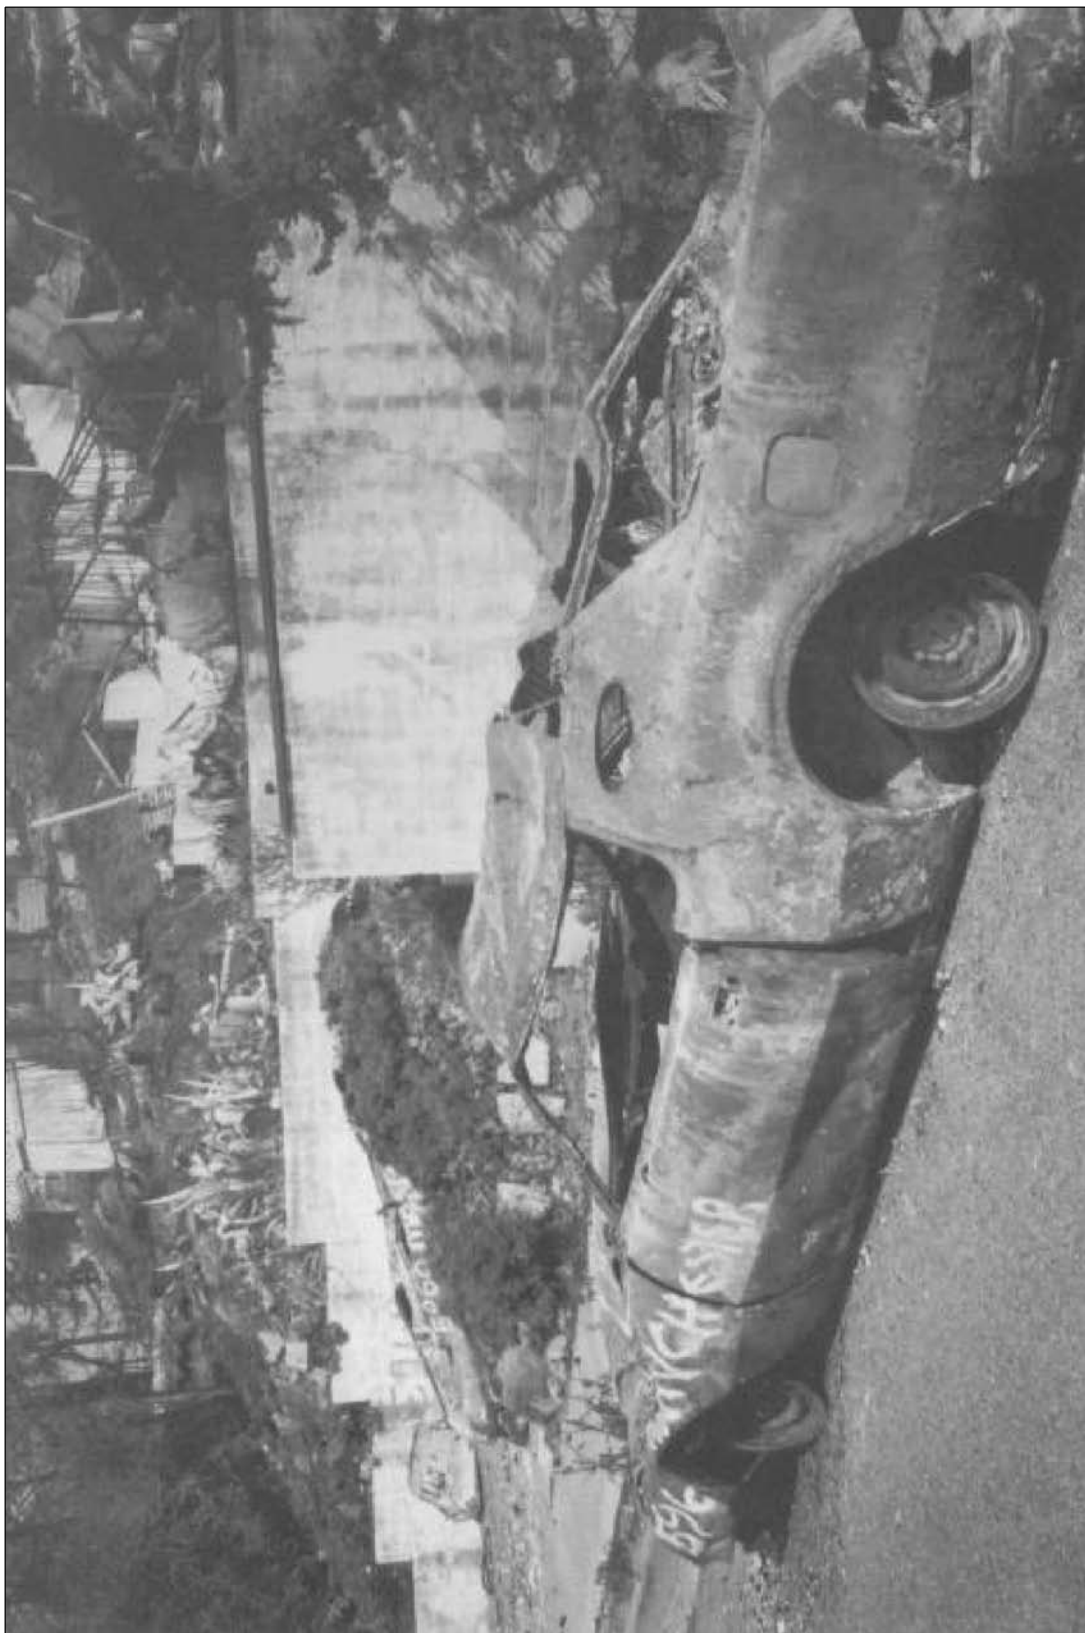
One of approximately 2,000 burned automobiles in the fire area.
